## MILESTONE INSPECTION REPORT

SHORE TOWERS

CONDOMINIUMS

2/6/24

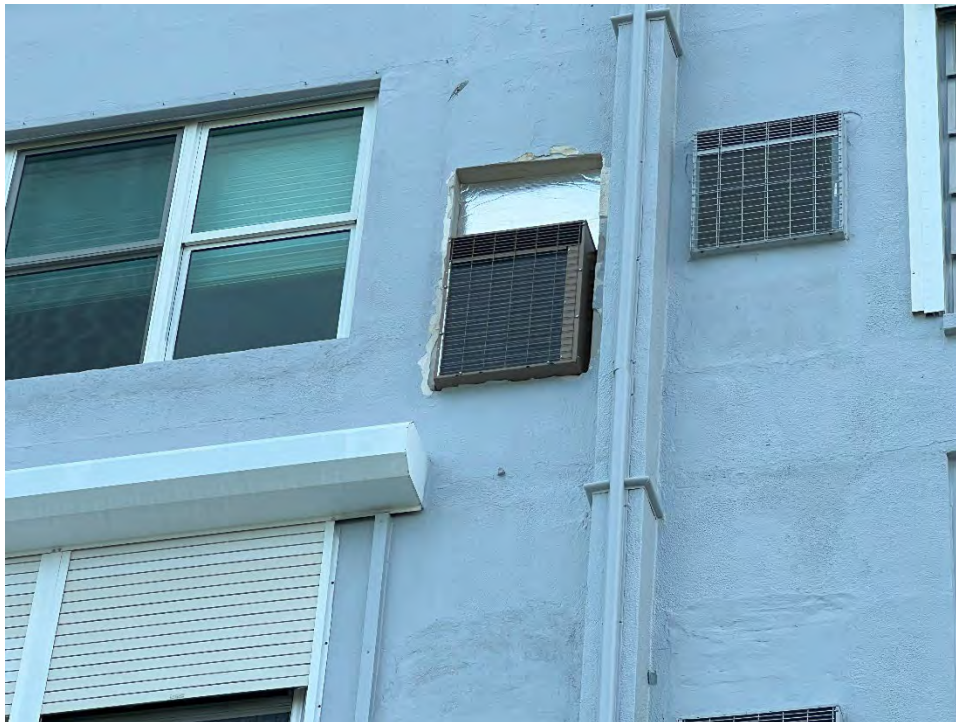
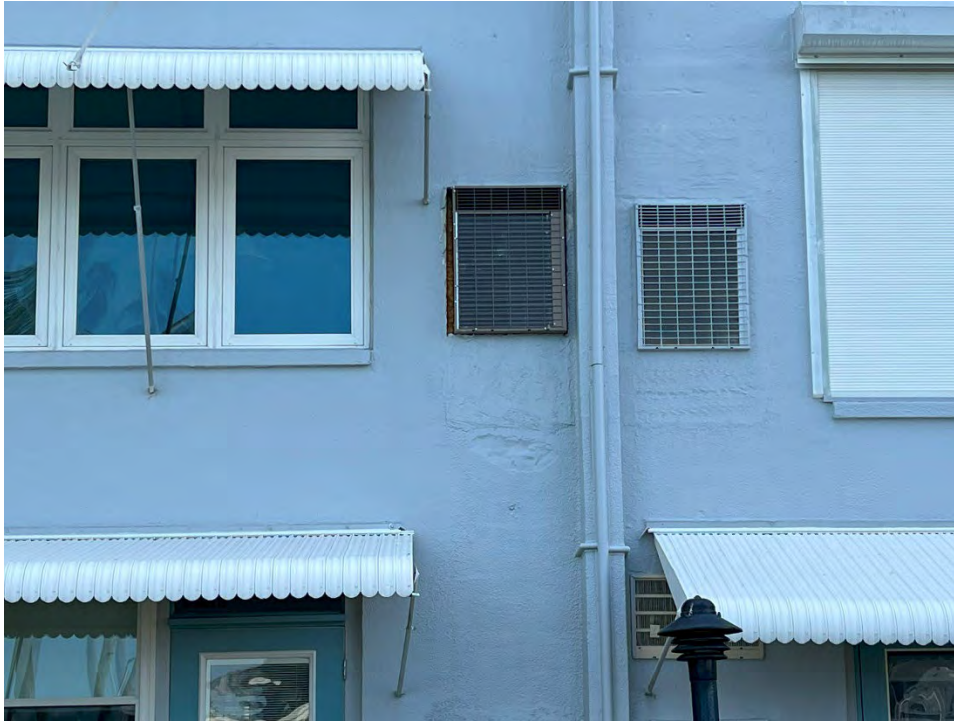
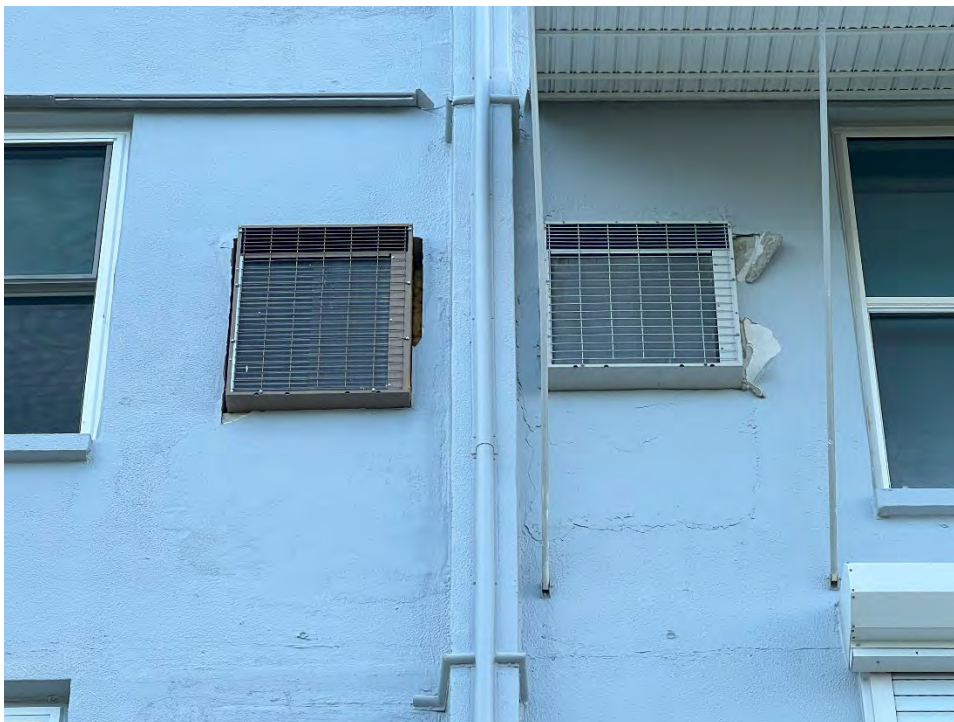
- Multiple unsealed gaps and separations through the exterior walls on the west elevation were observed along the perimeter of the air conditioning wall penetrations (Refer to Figure E-6 through Figure E-8).

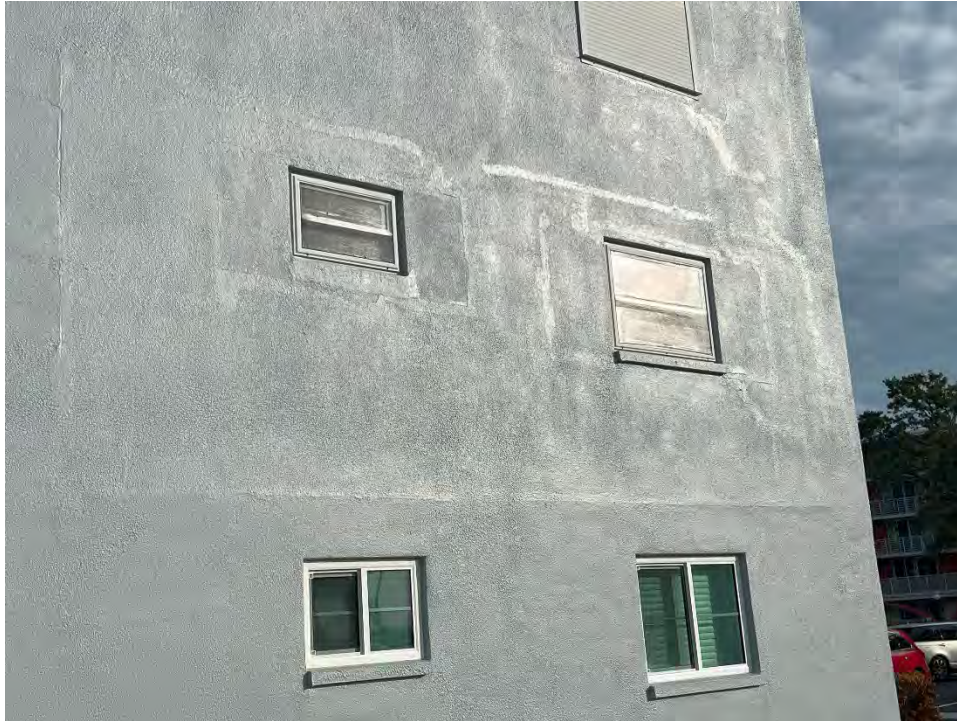
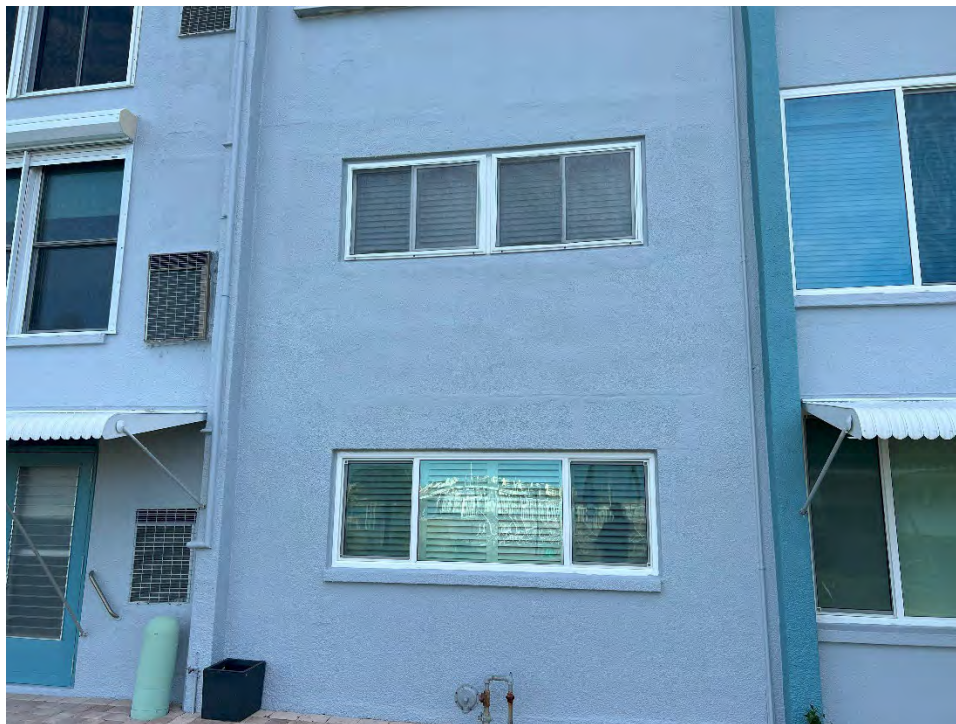
- Multiple previously sealed exterior wall cracks were observed with majority along transitions between cast-in-place reinforced concrete components and CMU infill walls, which is expected for a structure of this age and construction type (Refer to Figure E-9 and Figure E-10).

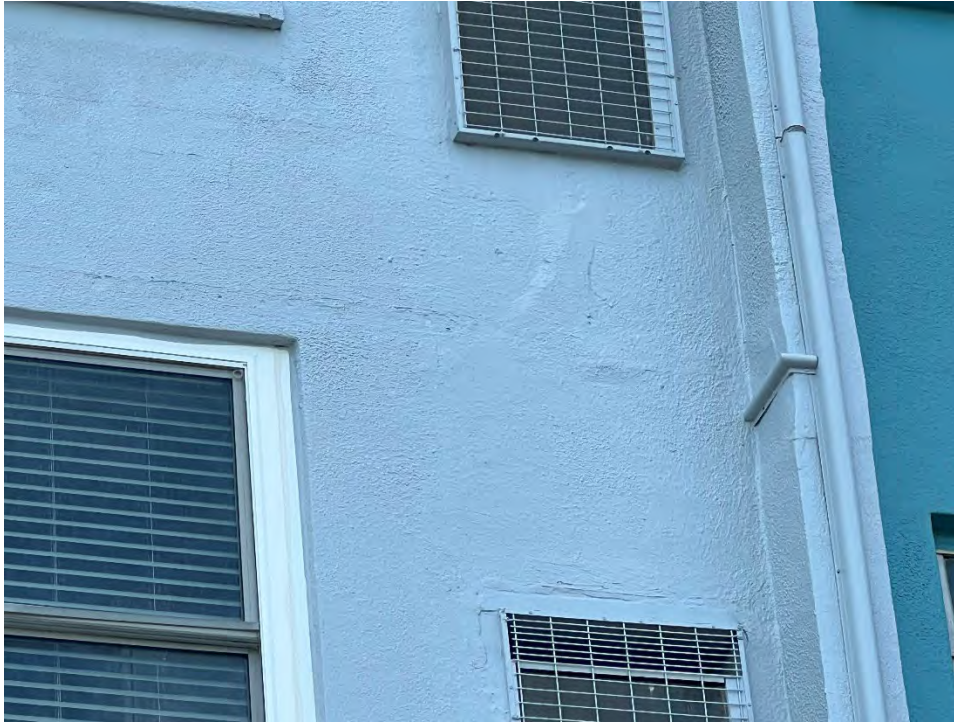
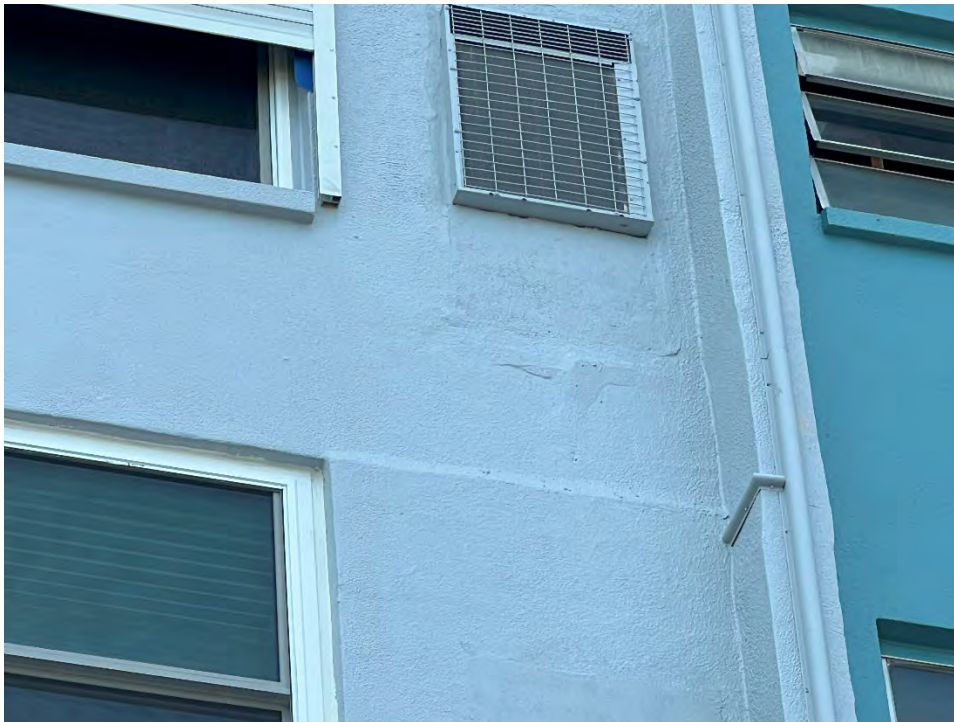
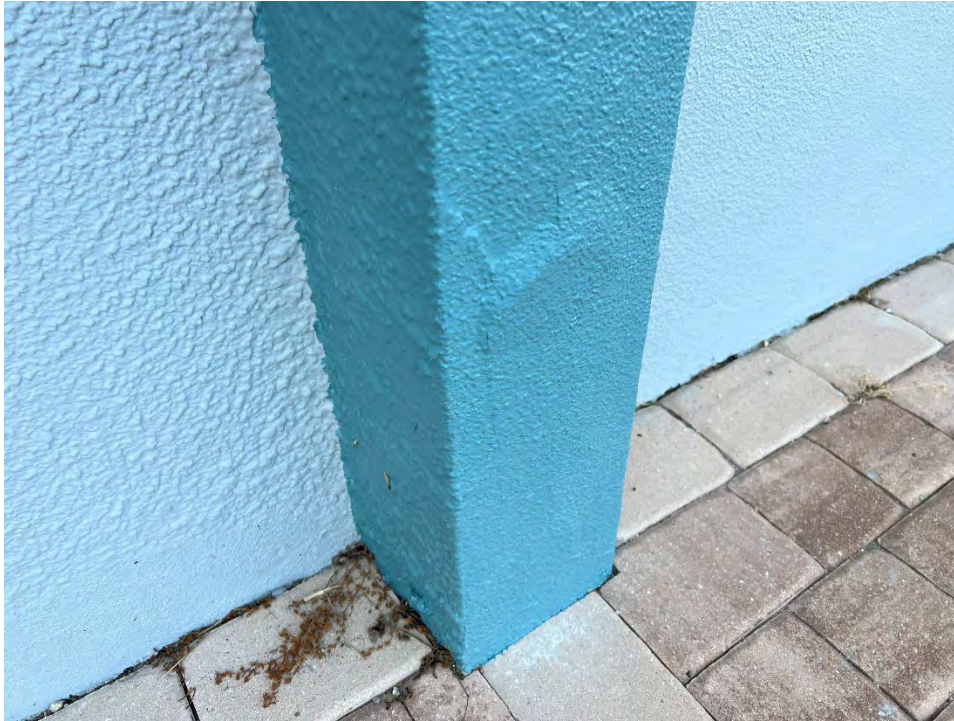
- Localized areas of delaminated exterior wall stucco finishes and/or concrete spalls were observed along the exterior wall surfaces (Refer to Figure E-11 through Figure E-13).

- Repair existing areas of delaminated, cracked and/or spalled exterior stucco finishes on the exterior wall surfaces along the building exterior elevations. Currently this condition does not appear to represent a serious structural condition, however if left unaddressed these areas will likely worsen and may develop into a more serious structural condition.
- Repair of gaps and separations around the perimeters of the air conditioning penetrations along the exterior wall surfaces on the west elevation . Currently this condition does not appear to represent a serious structural condition, however if left unaddressed these areas may develop into more serious structural conditions.

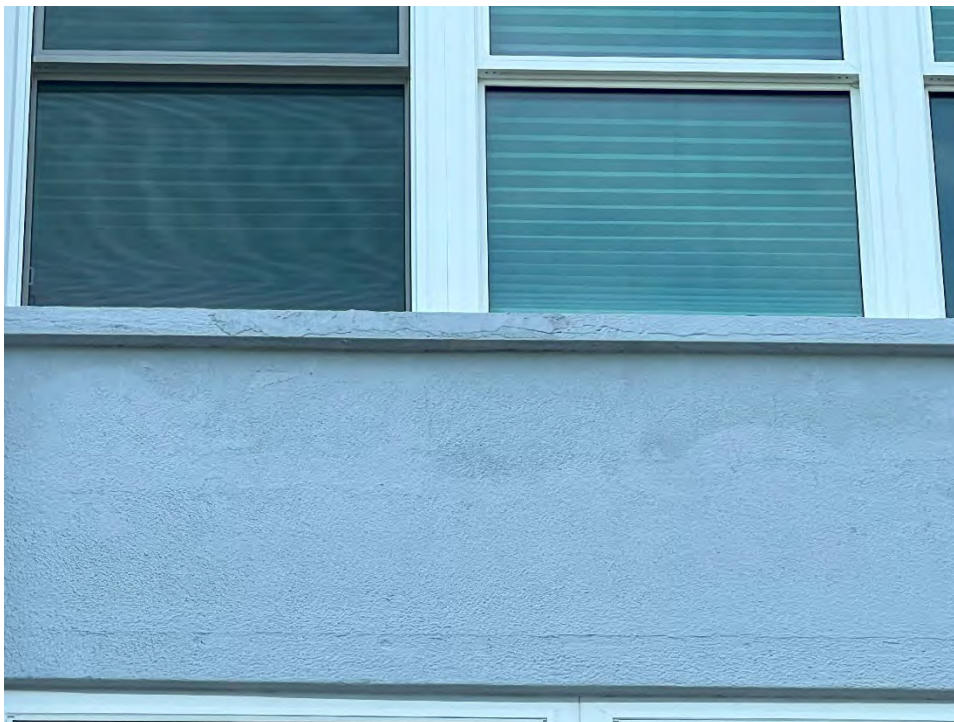
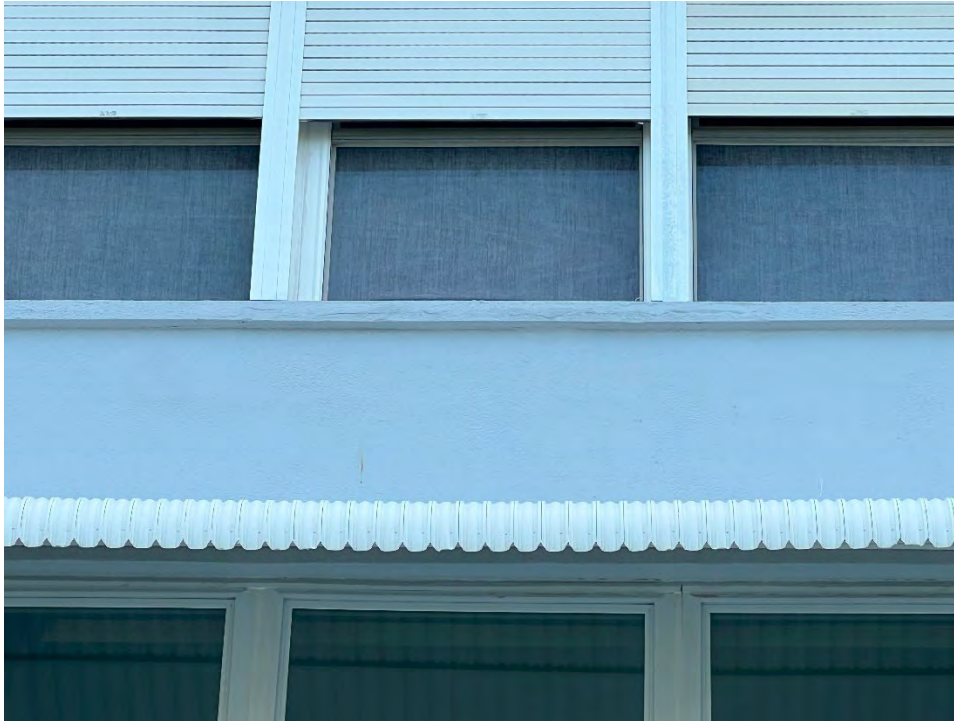
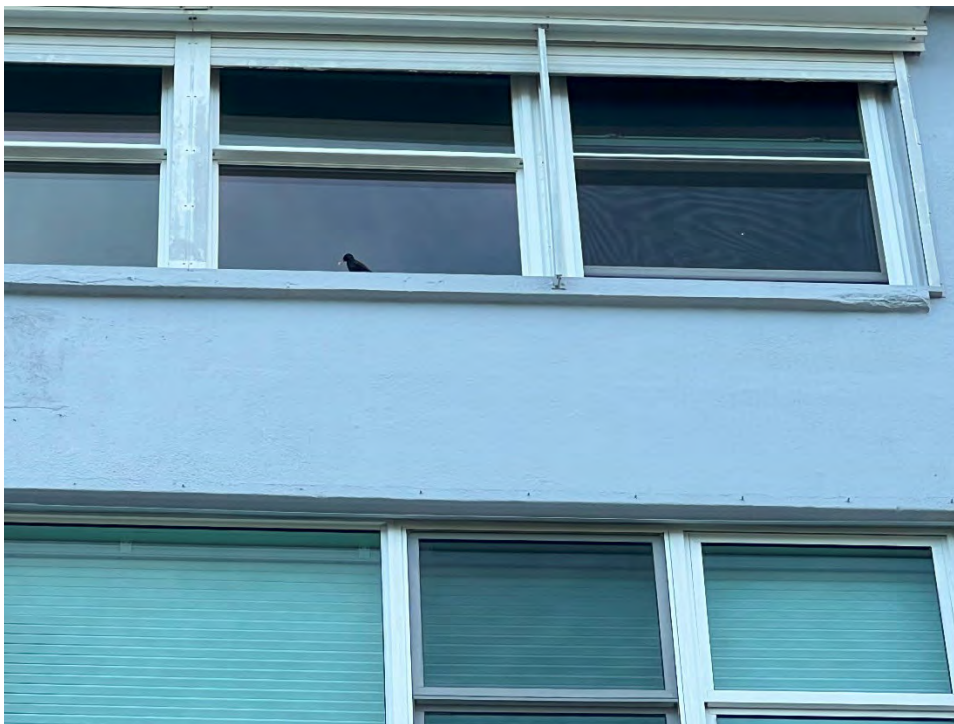
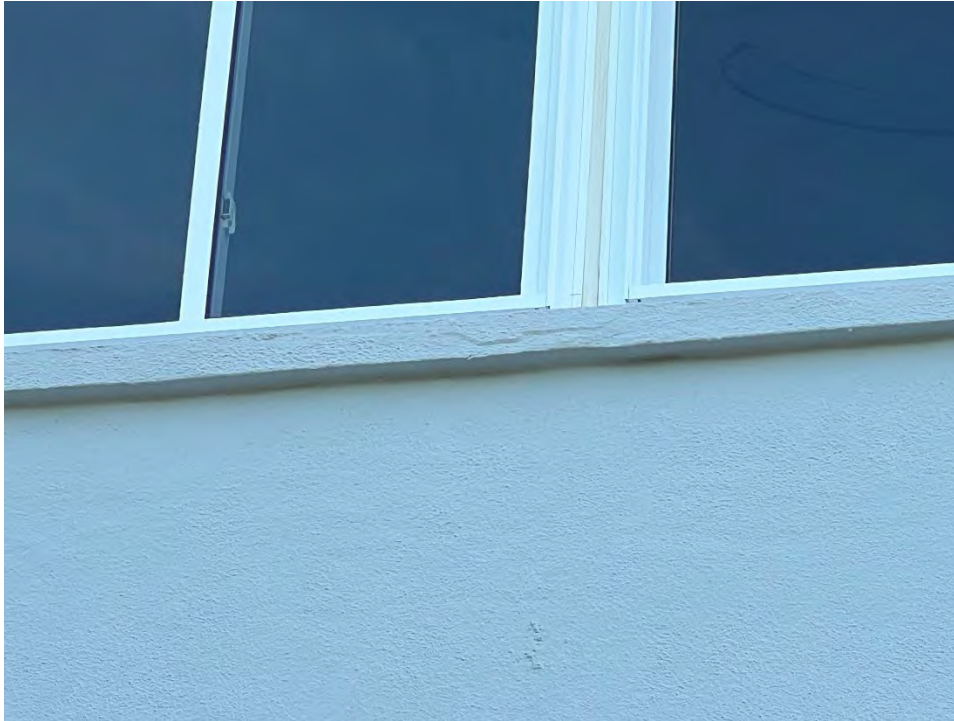
- Multiple areas of concrete spalls and/or cracks were observed on concrete windowsills (Refer to Figure E-14 through Figure E-17).
- The roof appears to be constructed of cast-in-place reinforced concrete elevated slabs. The roof covering appears to be a modified bitumen type roofing system (Figures E-18 and Figure E-19). The age and effectiveness of the roof covering is outside of the intent of the Milestone Inspection as Elevated Engineering understands it and therefore there are no comments on the current effectiveness of the roof covering.

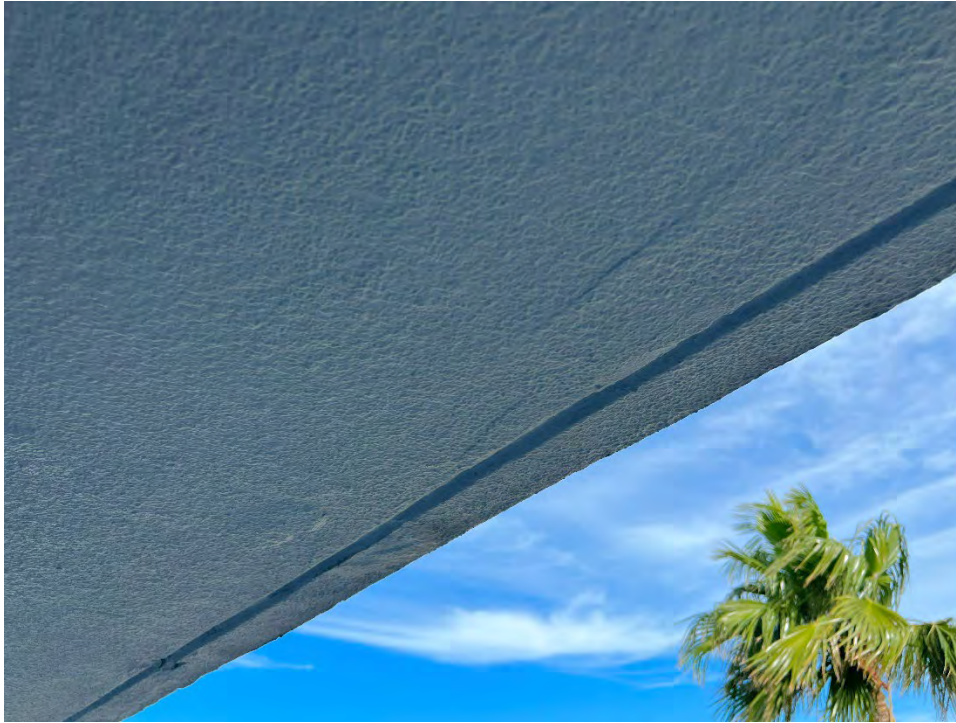
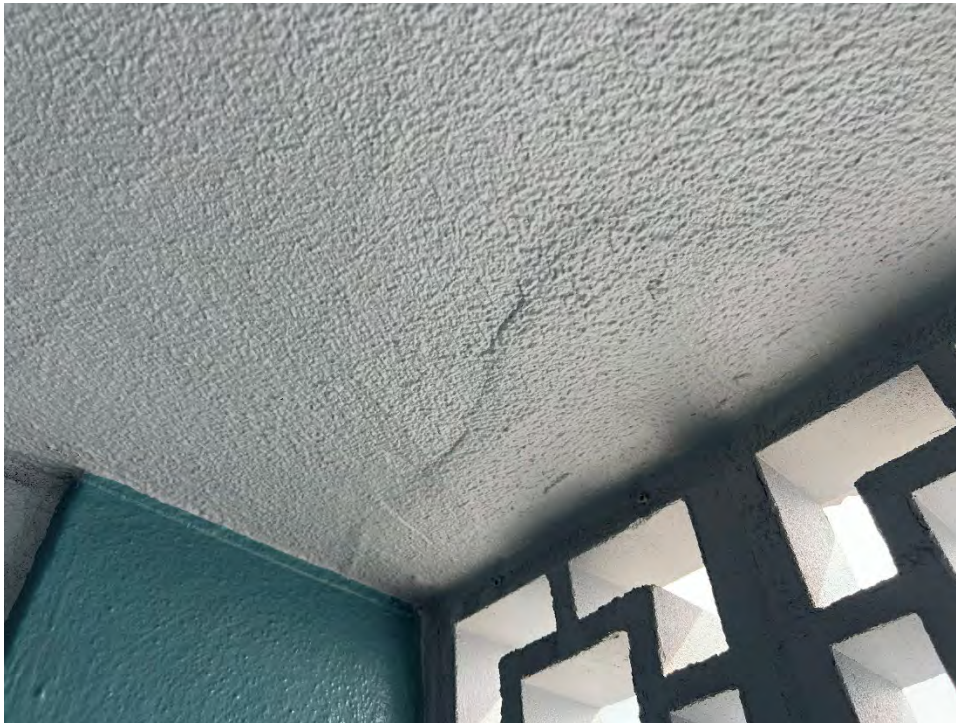
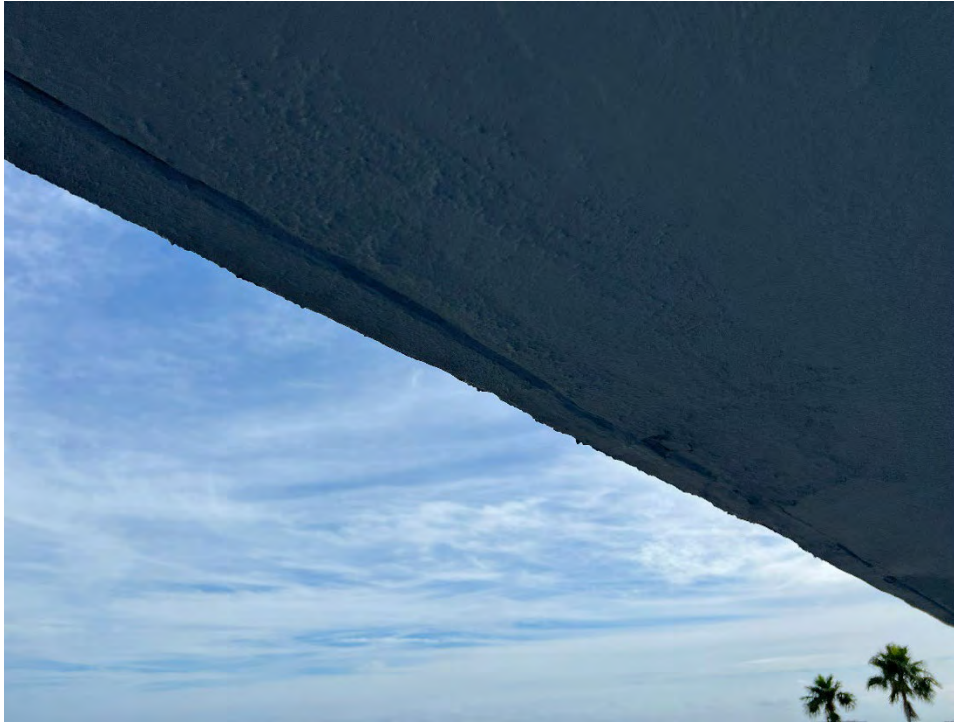
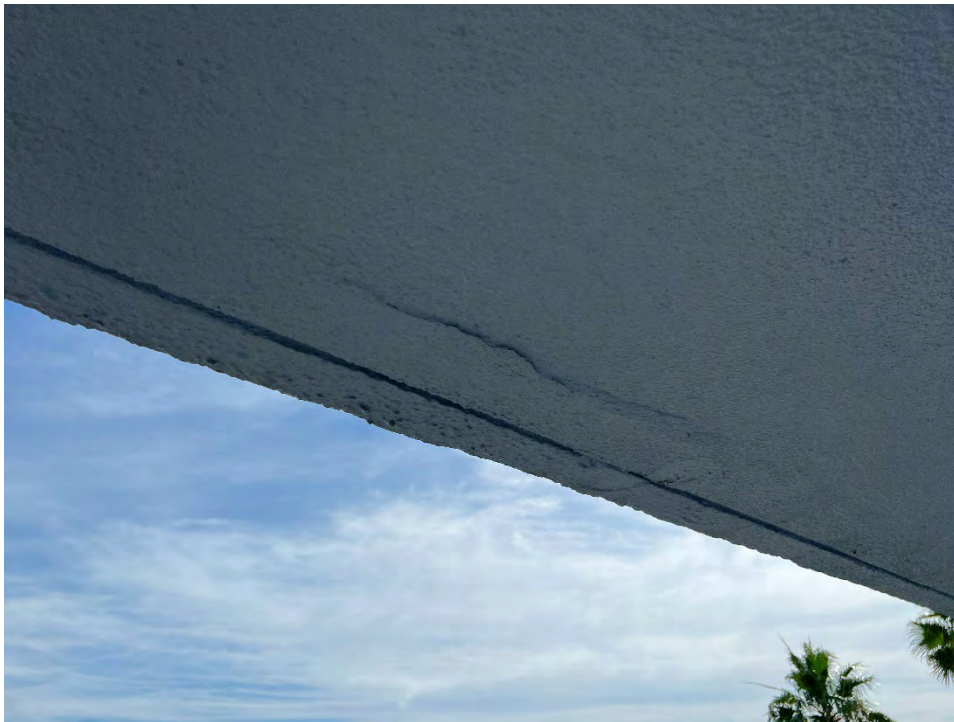
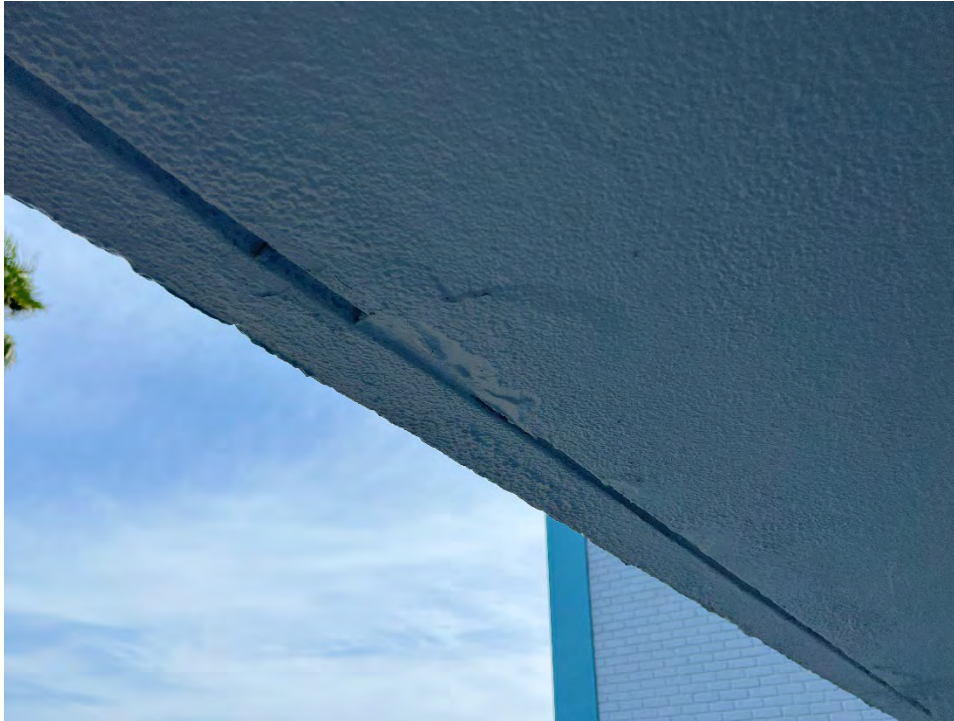
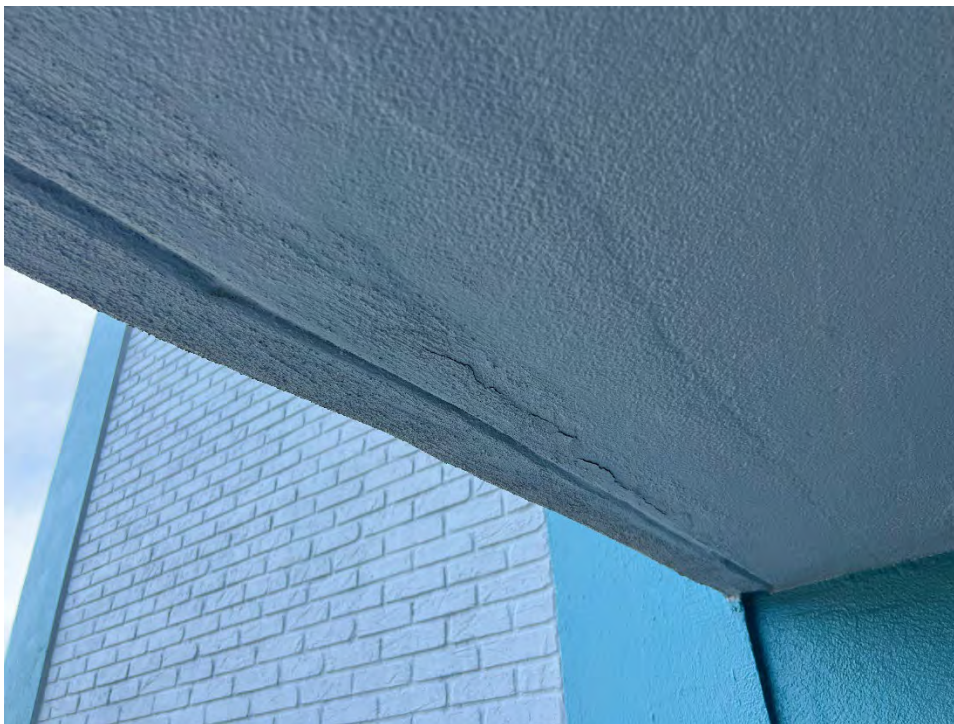
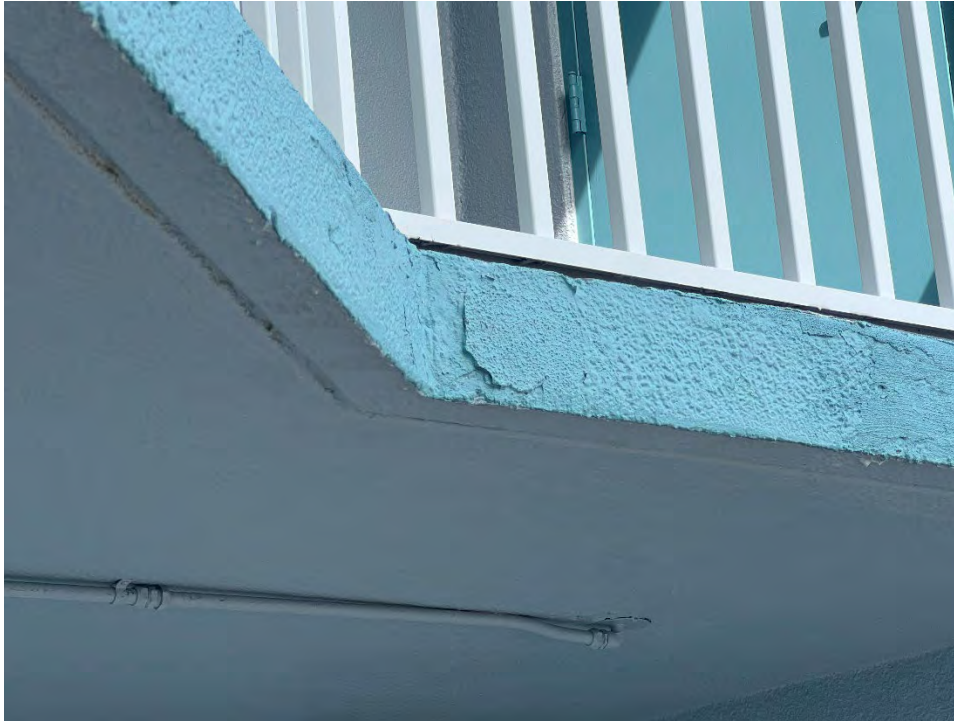
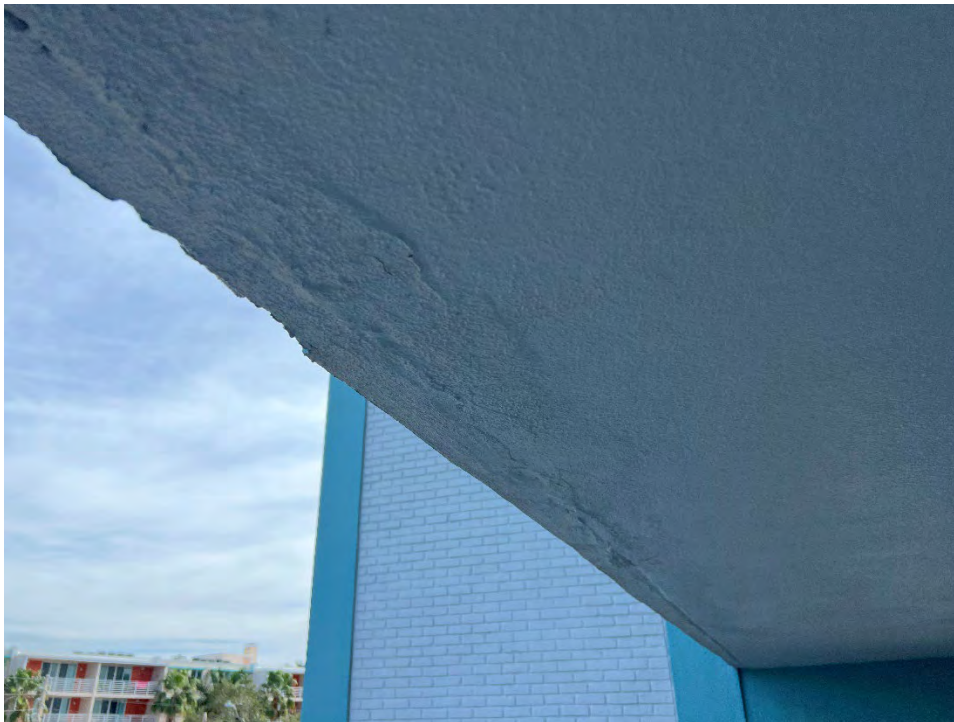
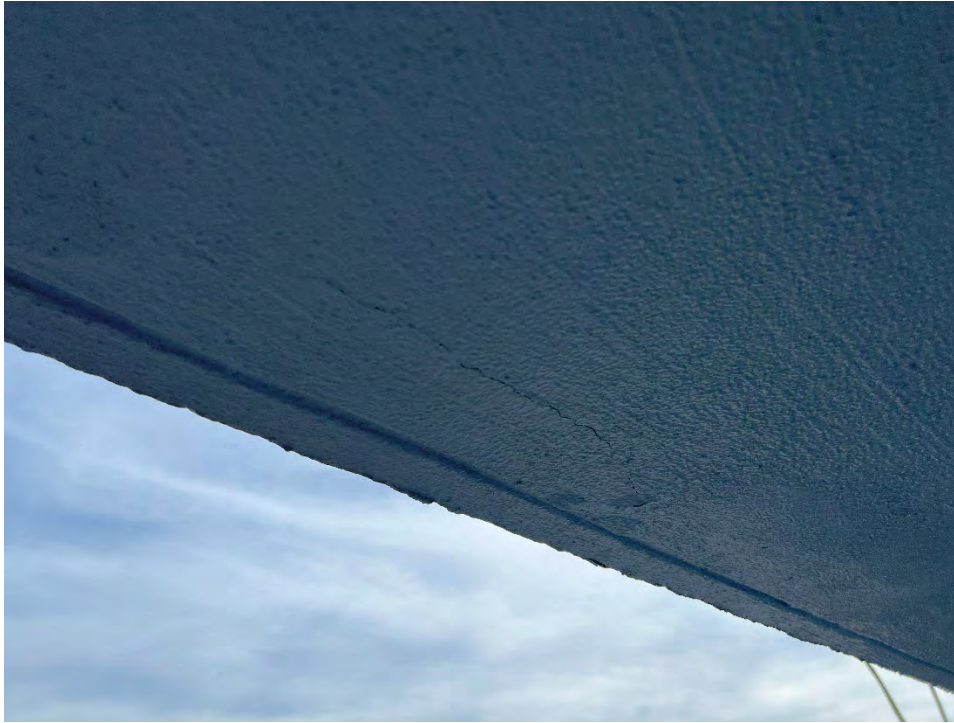
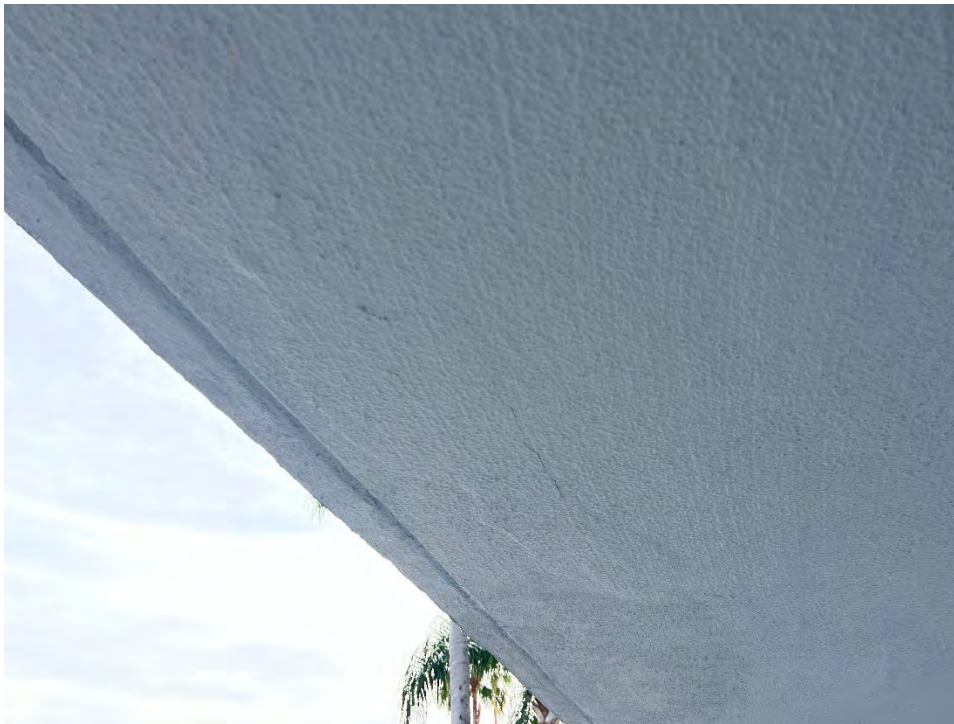
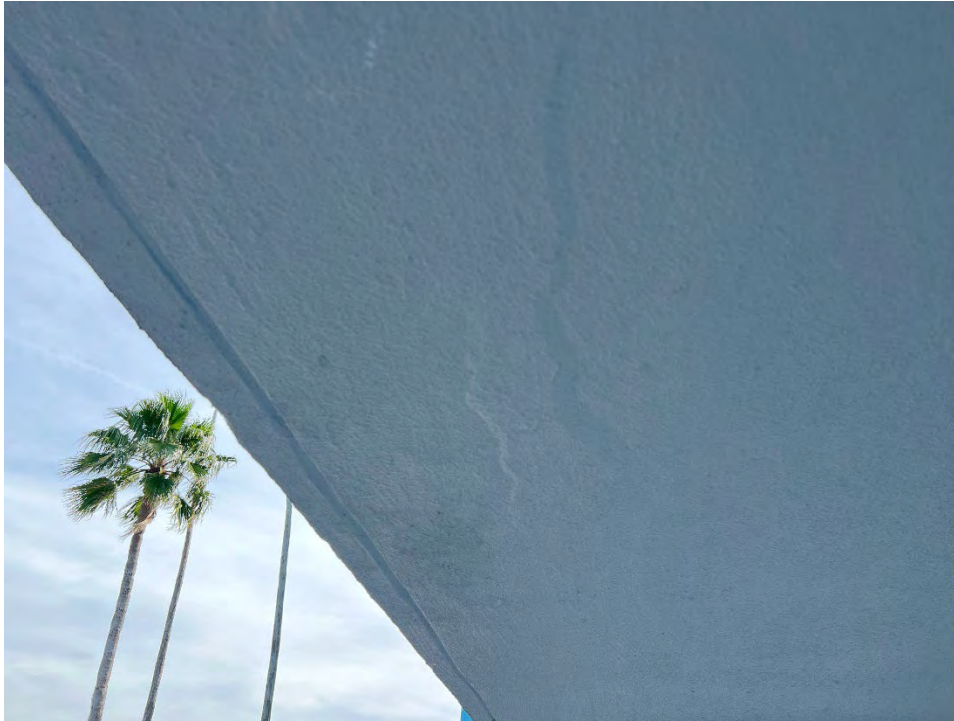
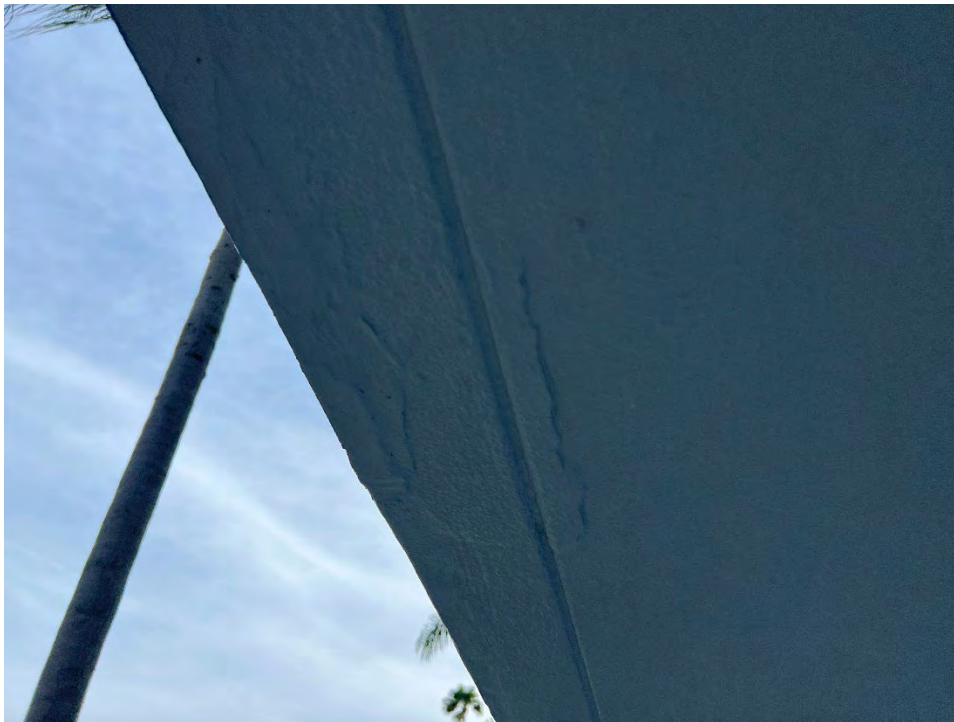
- Multiple areas of delaminated stucco finishes were observed along the underside and edge surfaces of the elevated concrete floor slabs.
- Multiple areas of unsound concrete and/or concrete spalls were observed along the underside and edge surfaces of the elevated concrete floor slabs with portions appearing to be failed previous repair attempts (Refer to Figure W-9 through Figure W-20).

- Repair existing areas of unsound concrete and concrete spalls along beams, and the underside and edge surfaces of the elevated concrete floor slabs of the exterior walkways. Currently this condition does not appear to represent a serious structural condition, however, concrete spalls need to be addressed as soon as possible as once concrete spalling starts the rate of additional corrosion increases rapidly, which leads to further concrete deterioration, which may develop into a more serious structural condition.

- Repair existing areas of delaminated, cracked and/or spalled exterior stucco finishes along the underside and edge surfaces of the elevated concrete floor slabs of the exterior

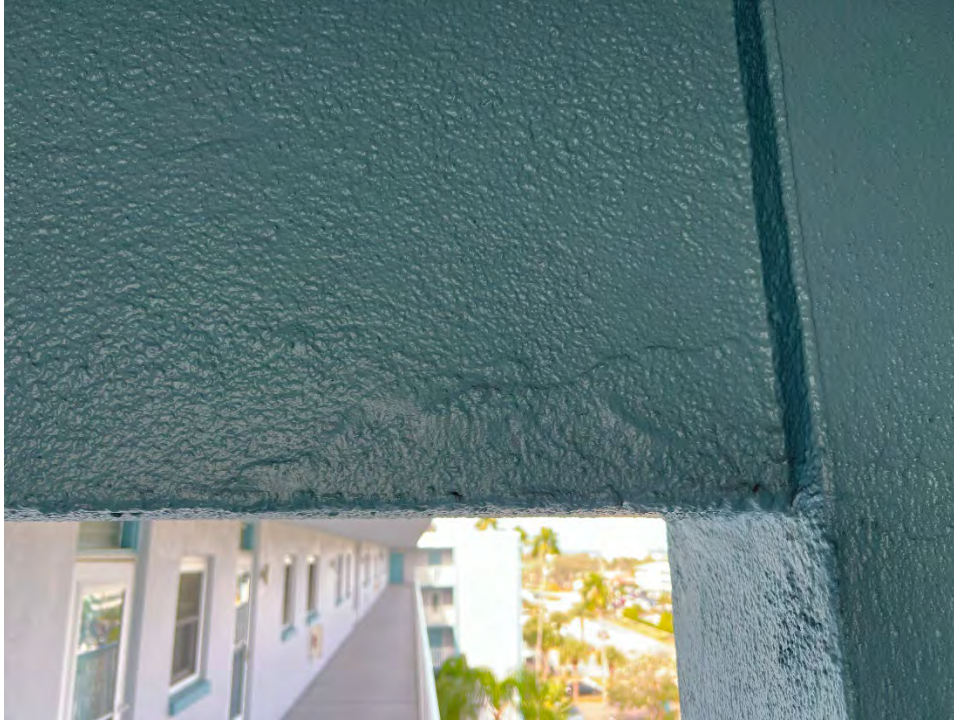
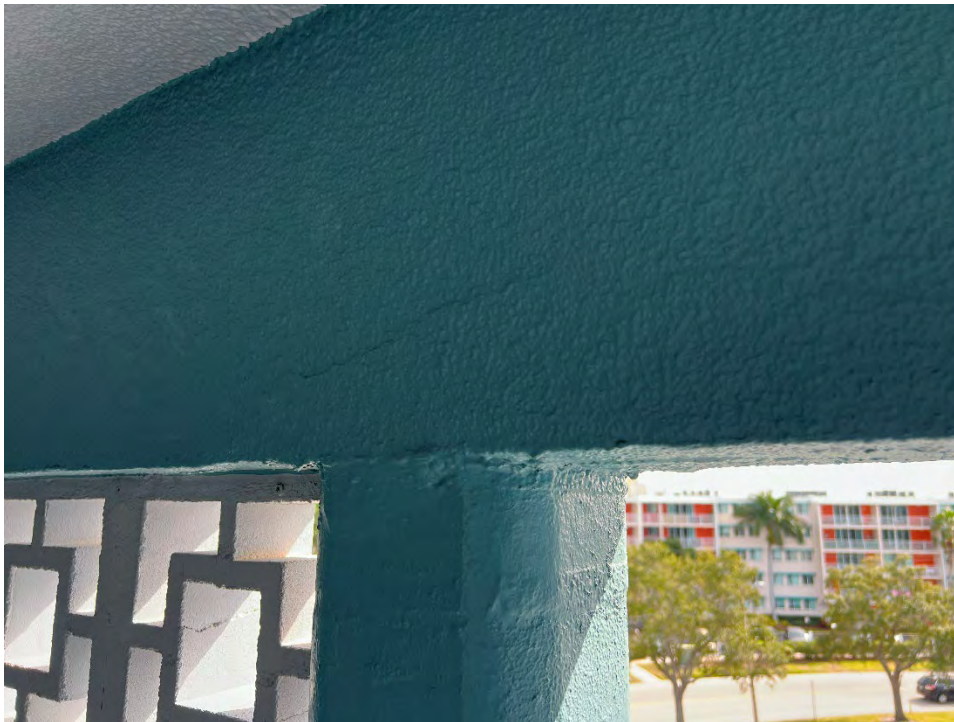
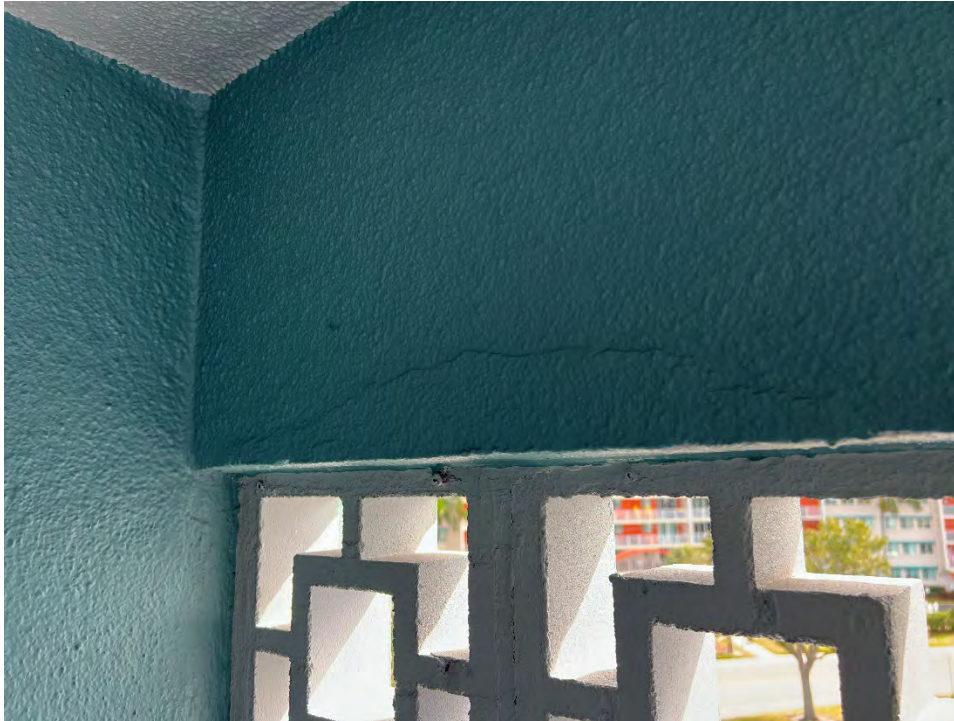
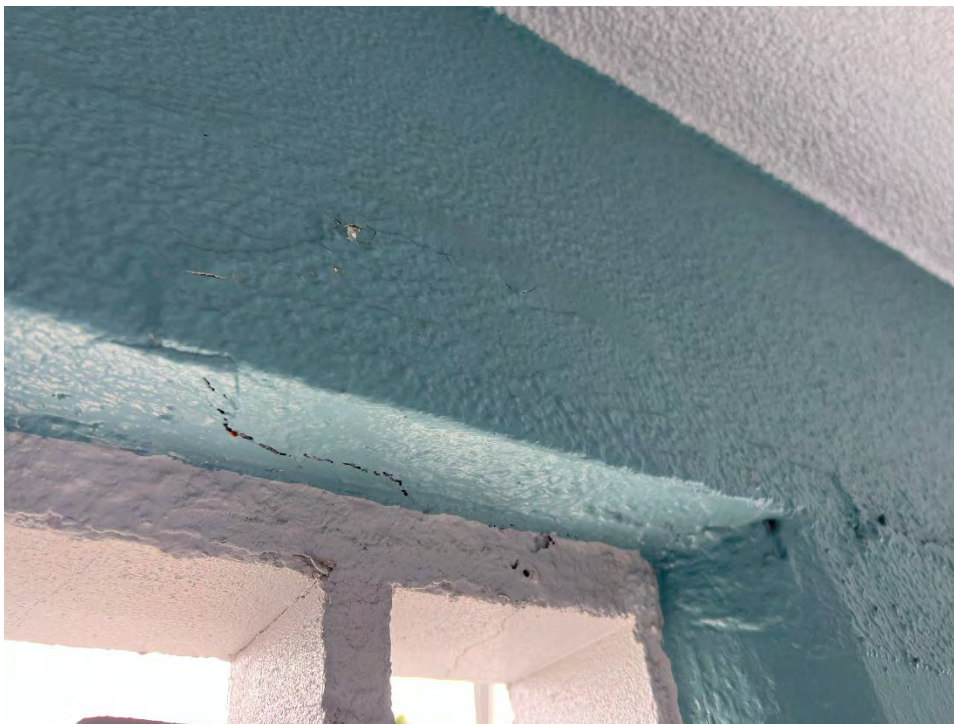
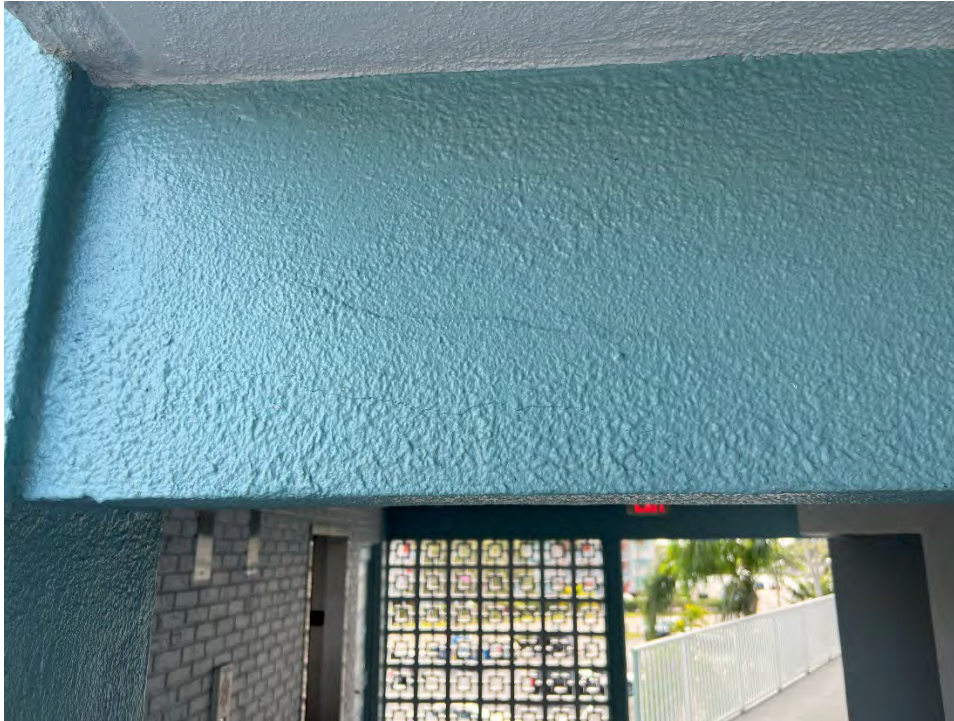
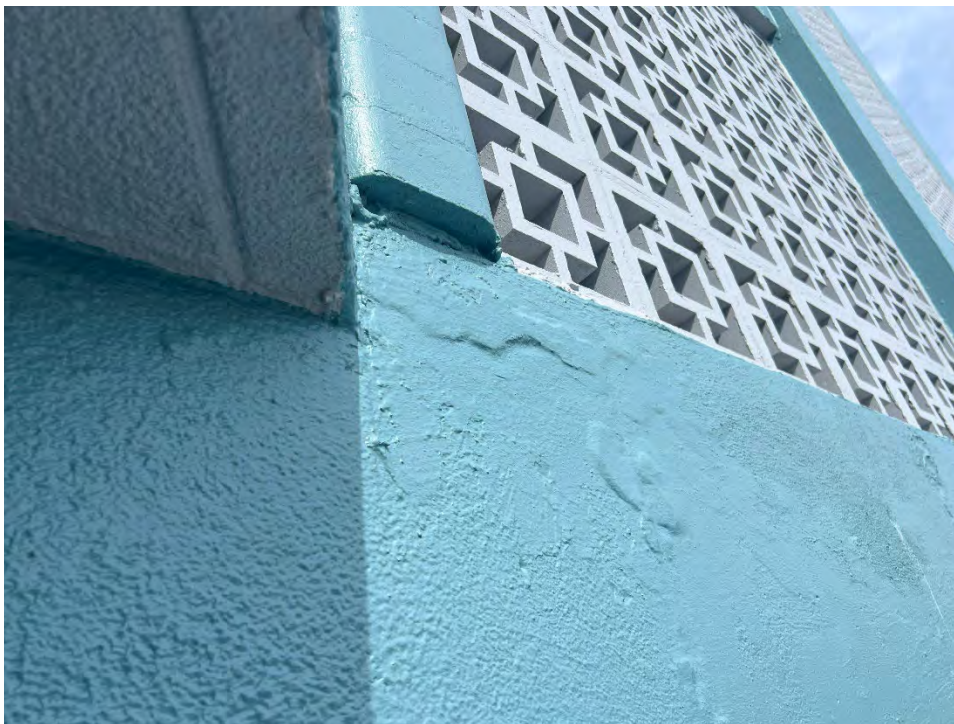
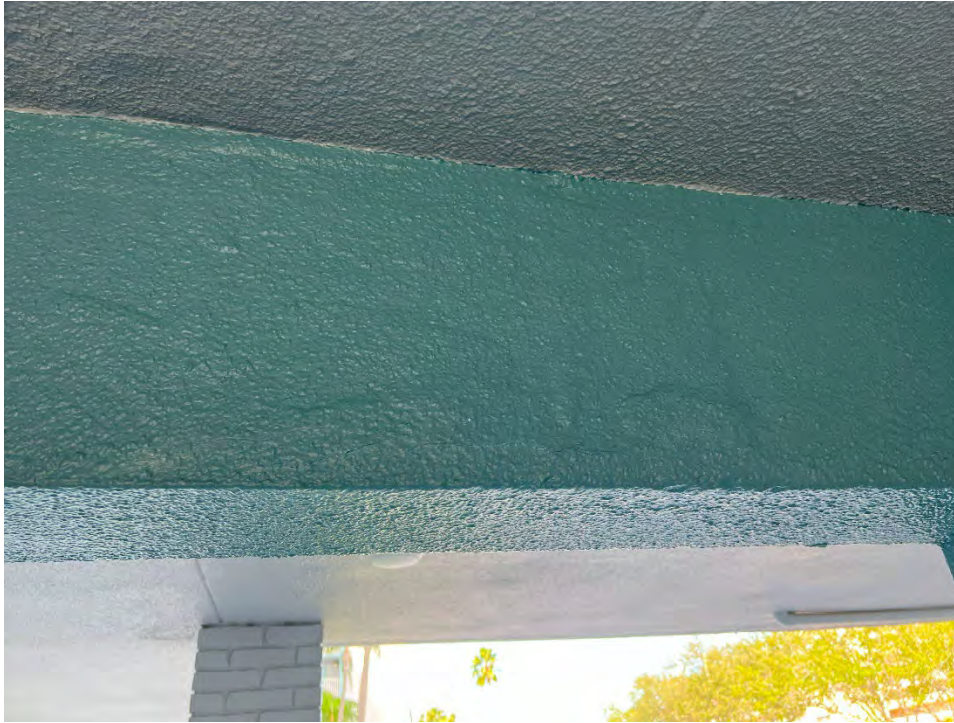
- Multiple areas of unsound concrete and/or concrete spalls were observed along concrete beams adjacent to elevators (Refer to Figure W-21 through Figure W-27).
