## MILESTONE INSPECTION REPORT

SHORE TOWERS

CONDOMINIUMS

2/6/24

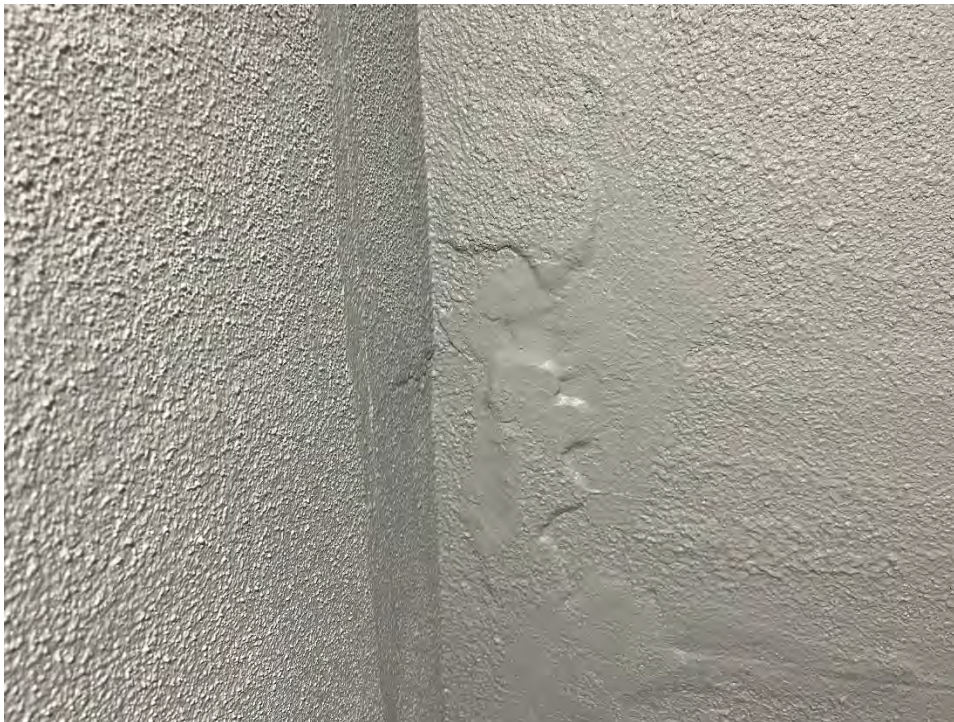
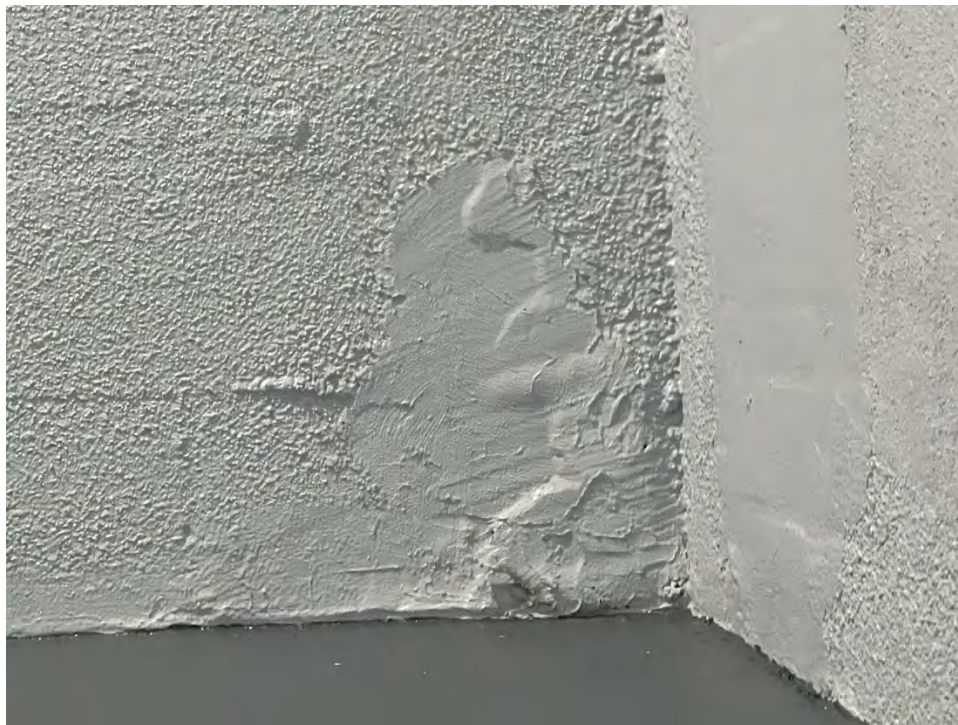
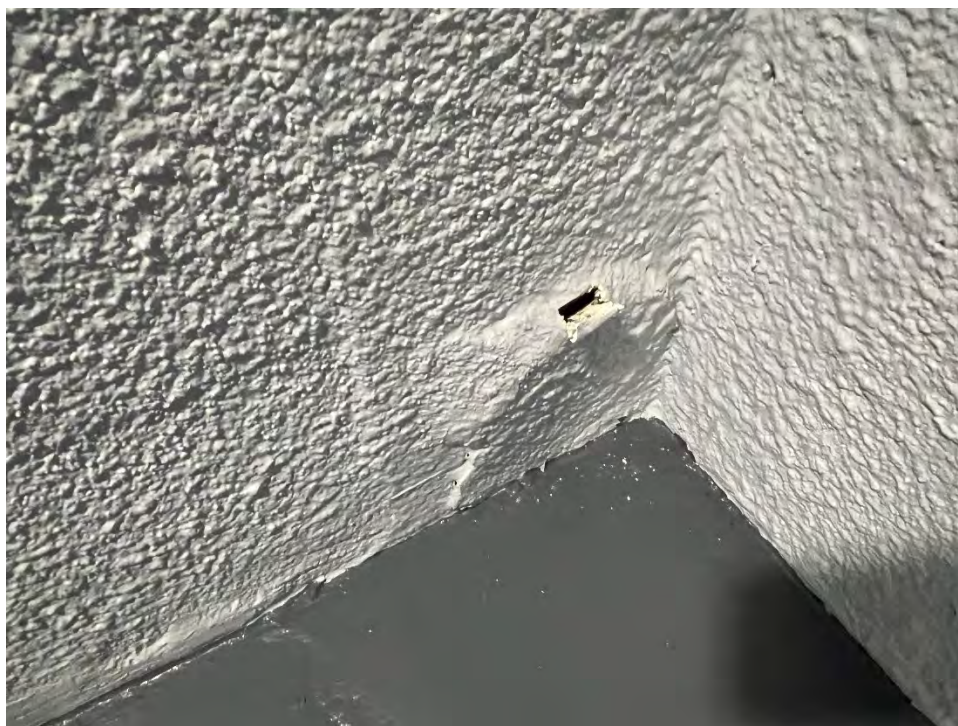
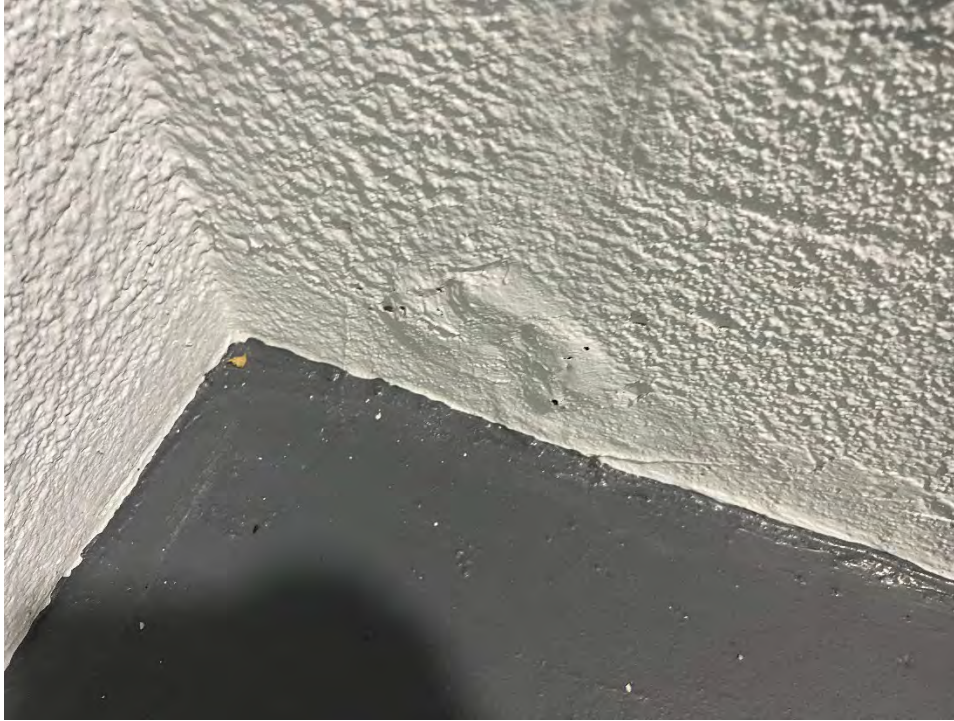
- Localized areas of unsound concrete and/or concrete spalls were observed along the interior faces of the concrete columns (Refer to Figure S-8 through Figure S-11).

- Repair existing areas of unsound concrete and concrete spalls along the concrete slab and column surfaces. Currently this condition does not appear to represent a serious structural condition, however, concrete spalls need to be addressed as soon as possible as once concrete spalling starts the rate of additional corrosion increases rapidly, which leads to further concrete deterioration, which may develop into a more serious structural condition.

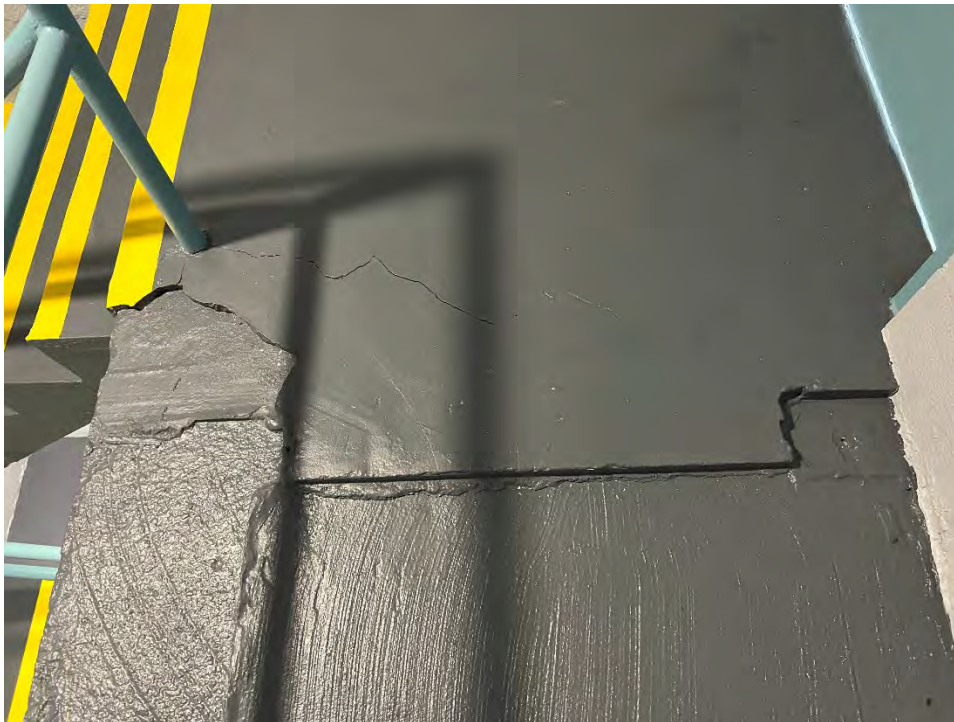
Figure S- 12

- Area of unsound concrete topping slab was observed on the 6<sup>th</sup> floor landing of the north stairway (Refer to Figure S-12).

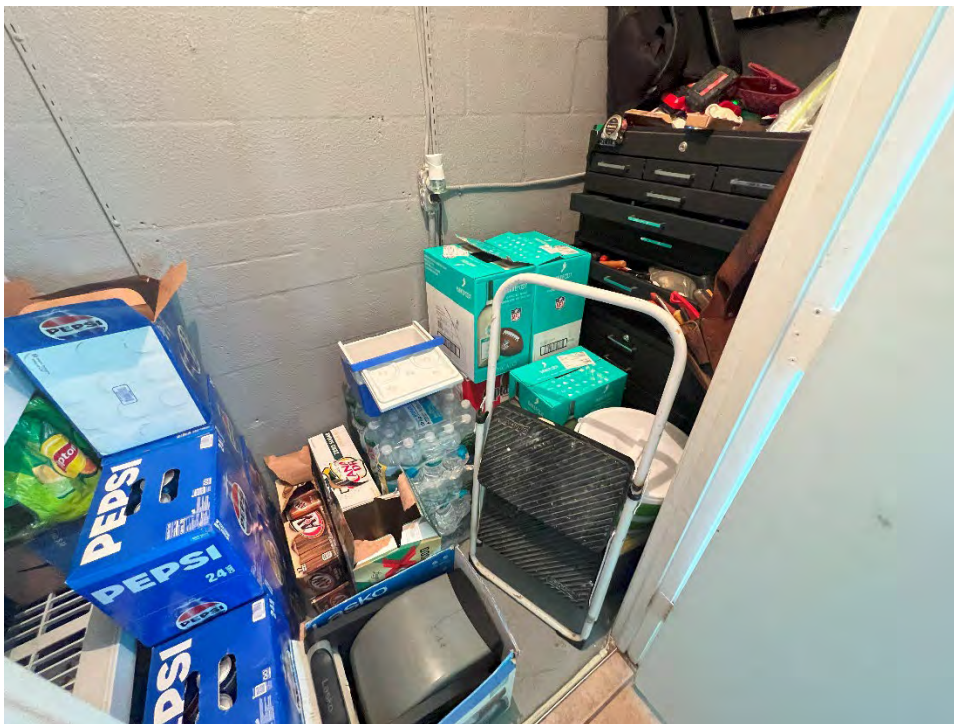
Figure U- 12

- Area of unsound concrete and/or concrete spall was observed along the top surface of the concrete floor slab in the air conditioning equipment closet of Unit 312 (Refer to Figure U-11). Please note the air conditioning equipment closets of multiple units were observed with stored items and floor finishes, which may be concealing other areas of unsound concrete and/or concrete spalls (Refer to Figure U-12).

- Repair existing areas of unsound concrete and concrete spalls along the top surfaces of the floor slab of the air conditioning equipment closets. Currently this condition does not appear to represent a serious structural condition, however, concrete spalls need to be addressed as soon as possible as once concrete spalling starts the rate of additional corrosion increases rapidly, which leads to further concrete deterioration, which may develop into a more serious structural condition.
