Windstorm Mitigation Report

Shore Towers Building of Town Apartments South No. 103

South Pasadena, FL

As of 03-25-2024 | FPAT File# MUD2422151

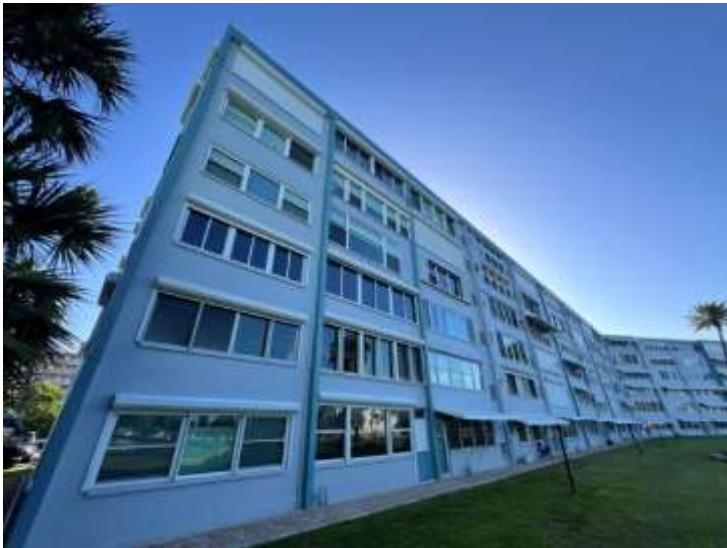
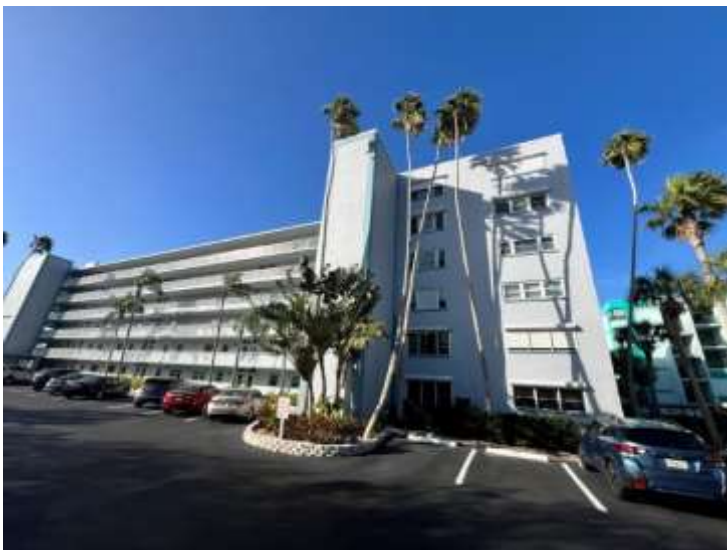
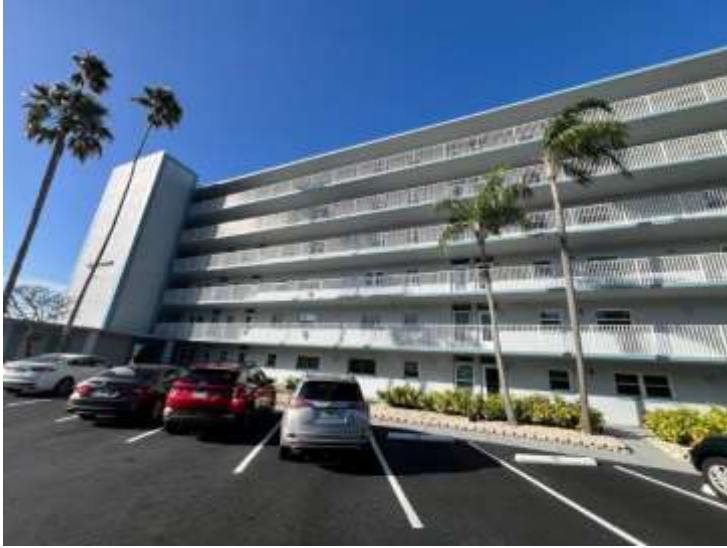
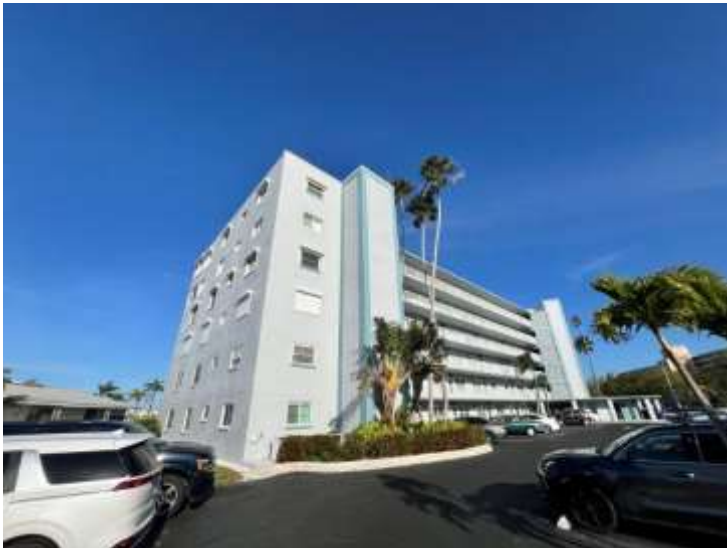
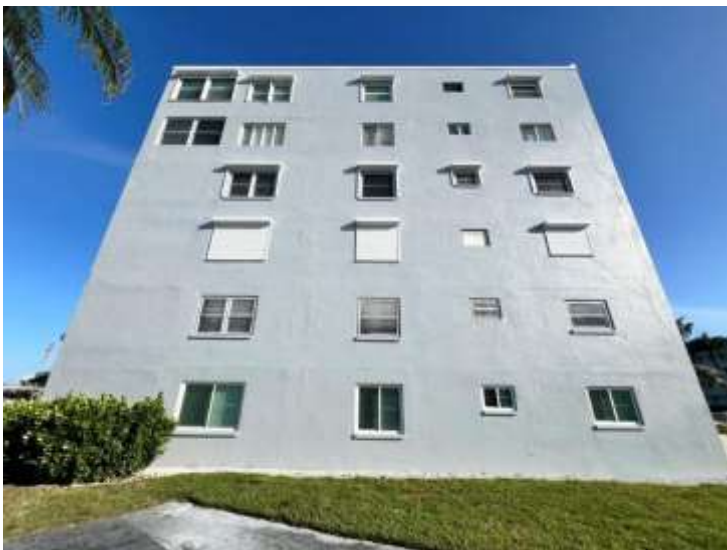
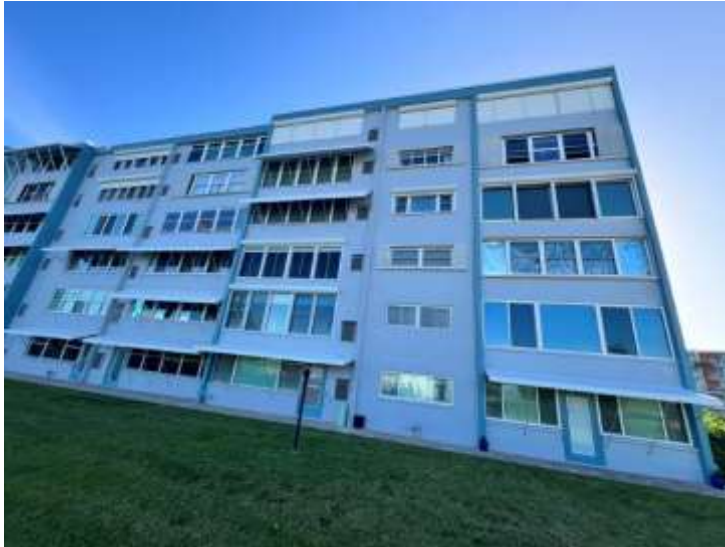
Exterior Elevation

Comments: | None or Some Glazed Openings
No opening protection verified at the time of inspection. |

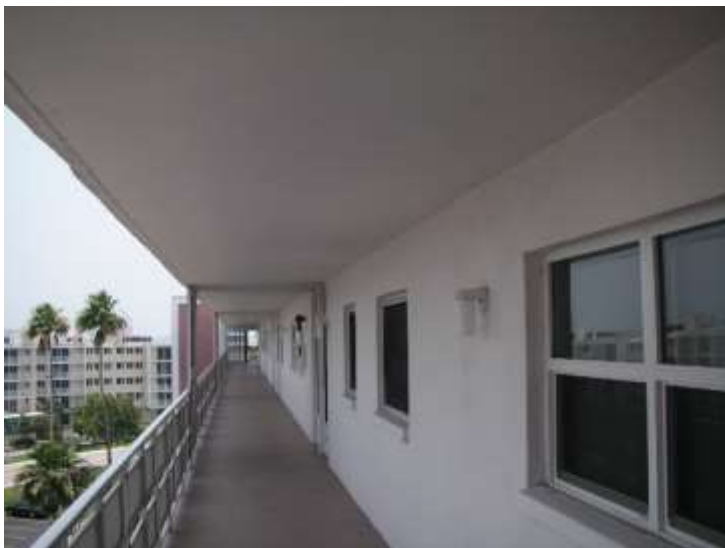
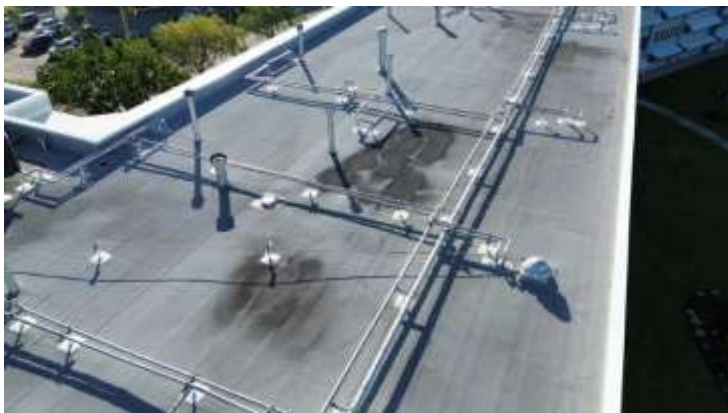
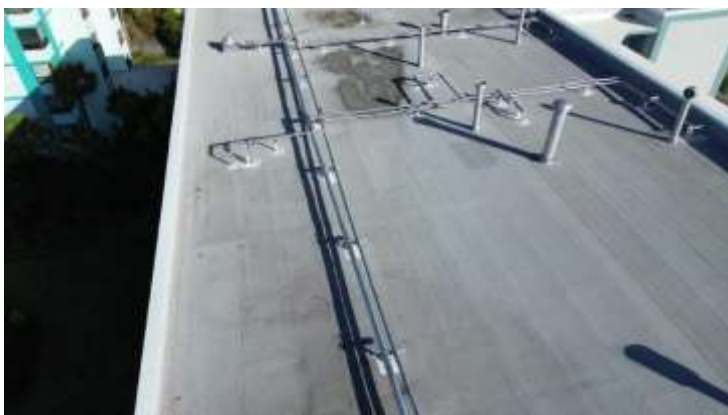
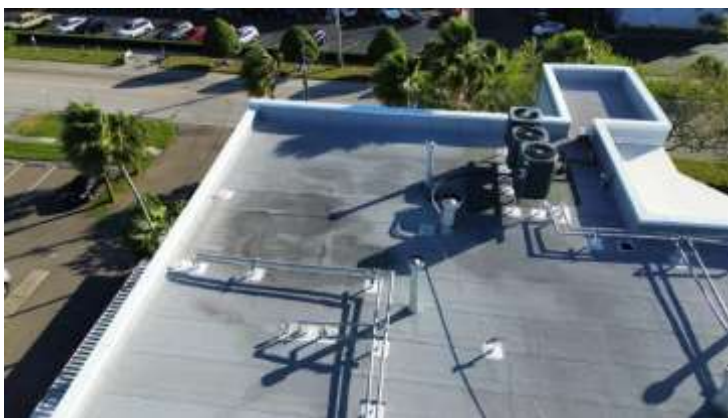
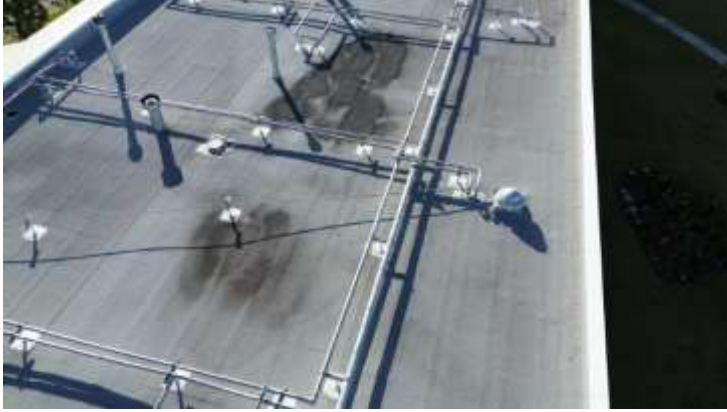
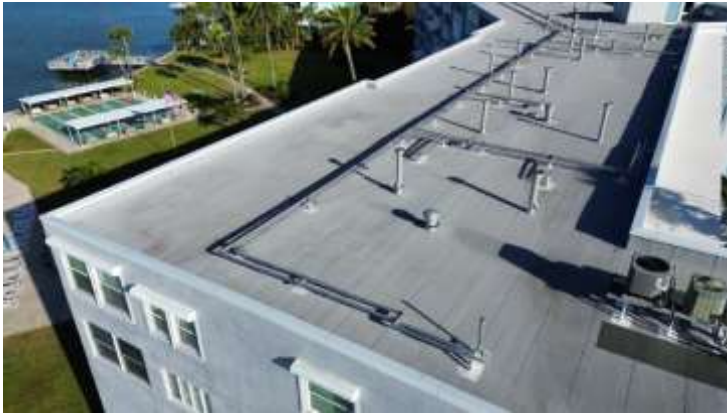
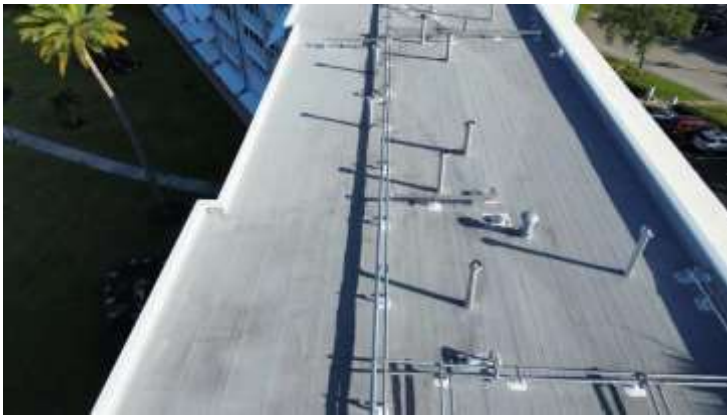
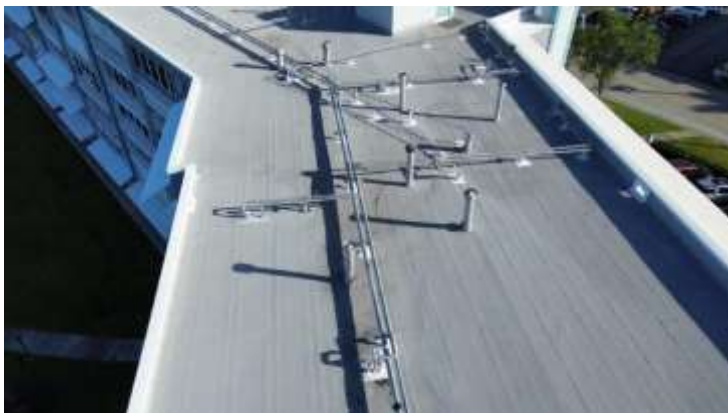
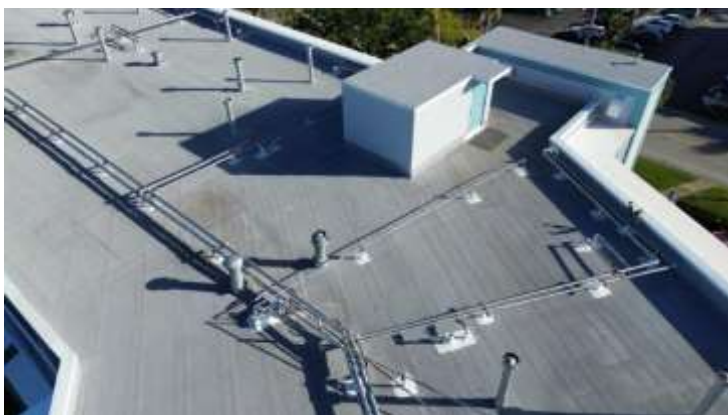
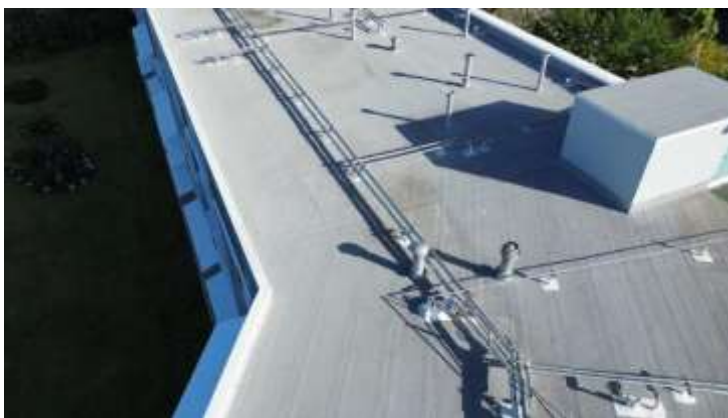
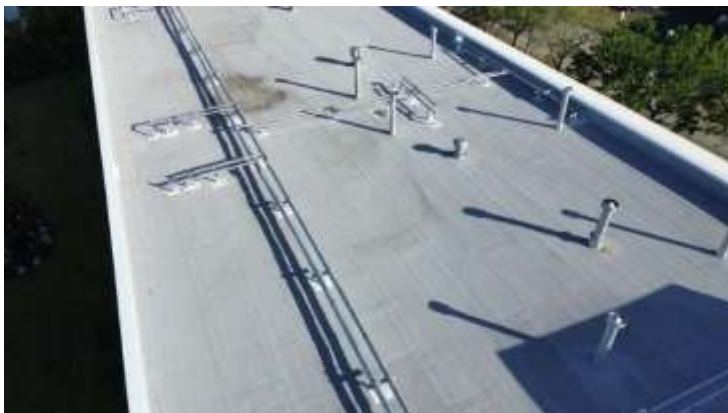
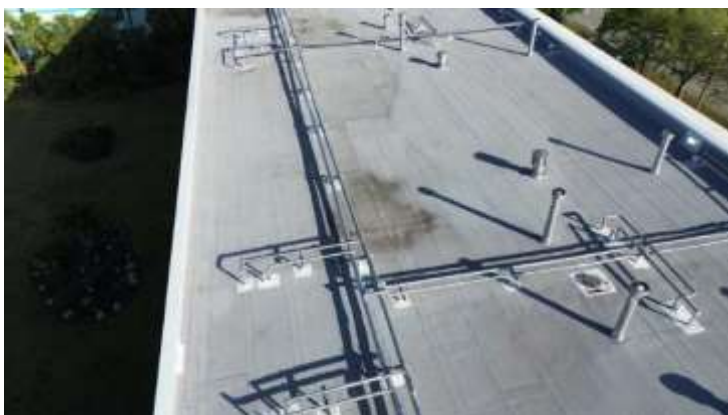
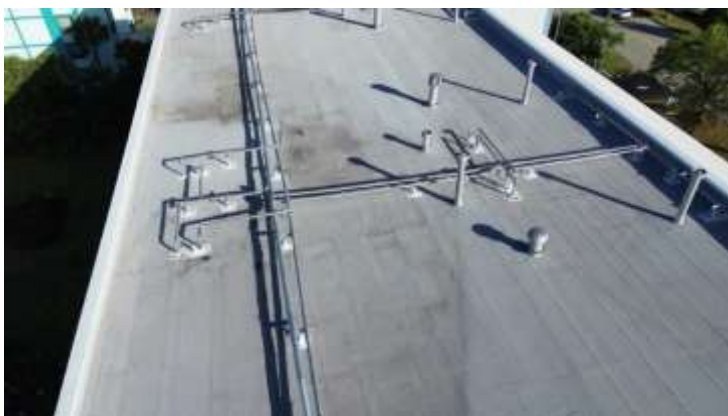
Roof Construction

Comments: | Reinforced Concrete Roof Deck
Inspection verified a roof structure composed of cast-in-place or pre-cast structural concrete designed to be self-supporting and integrally attached to the wall / support system. |

Comments: | Structural
Inspection verified a roof structure composed of cast-in-place or pre-cast structural concrete designed to be self-supporting and integrally attached to the wall / support system. |

Comments: | Flat Roof
Inspection verified flat roof shape, refer to attached photographs. |

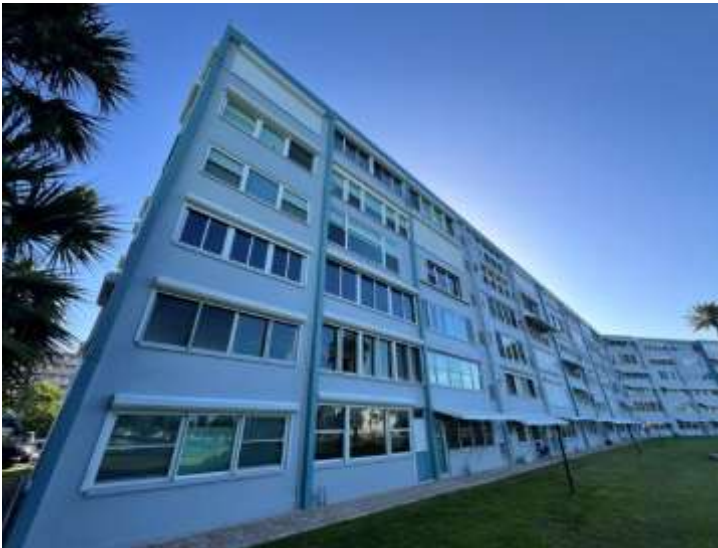
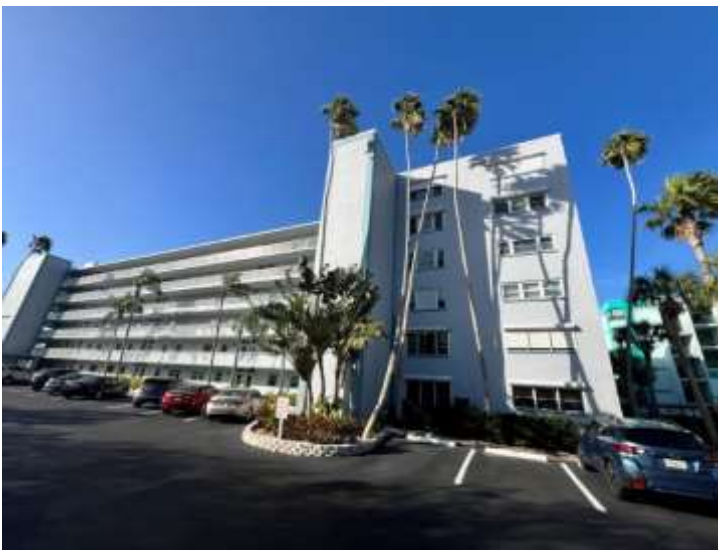
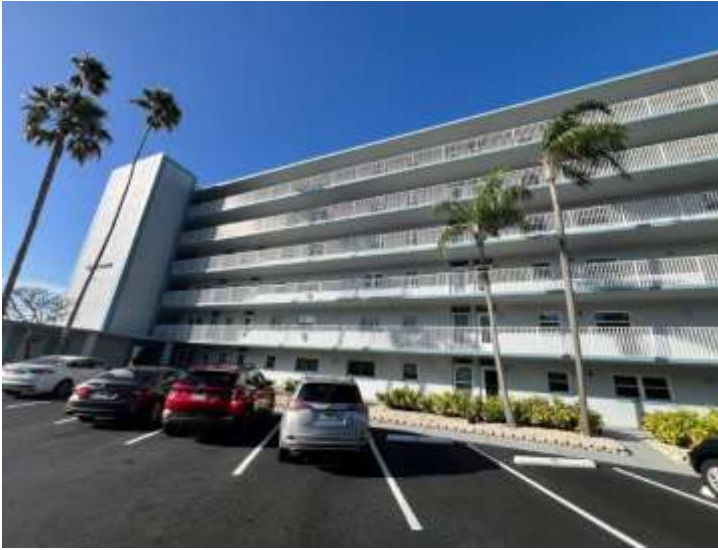
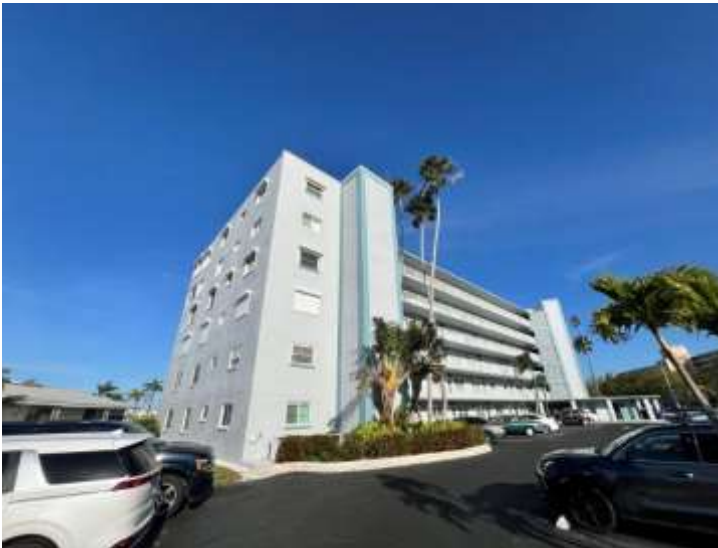
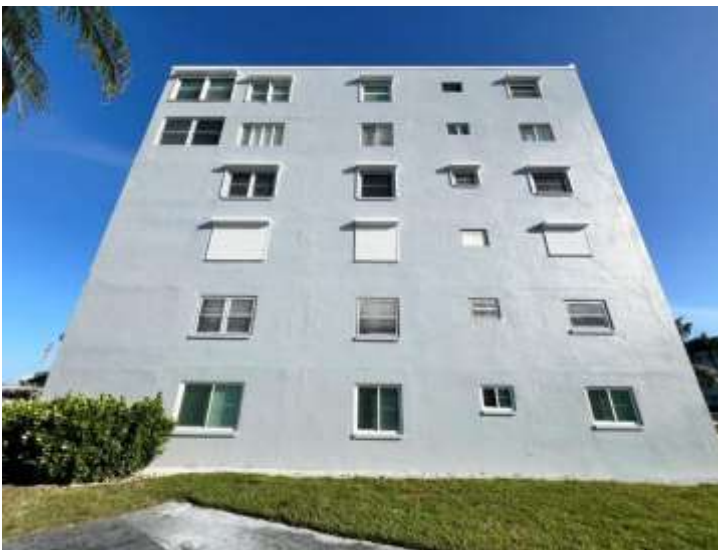
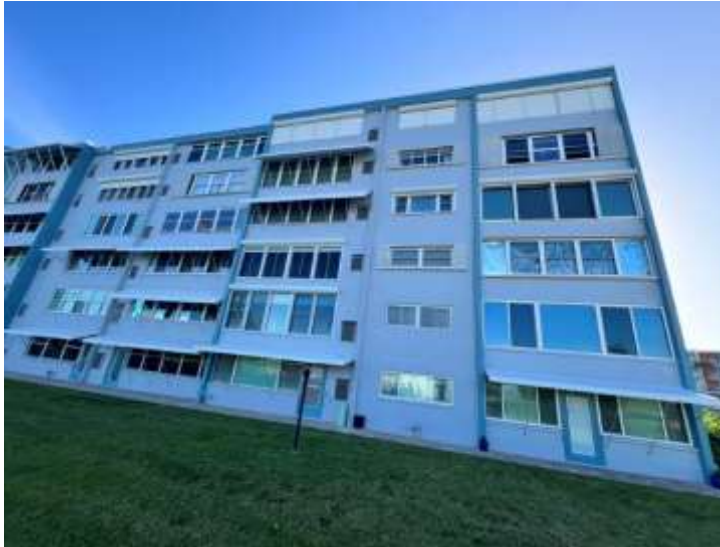
Exterior Elevation

Comments: | None or Some Glazed Openings
No opening protection verified at the time of inspection. |

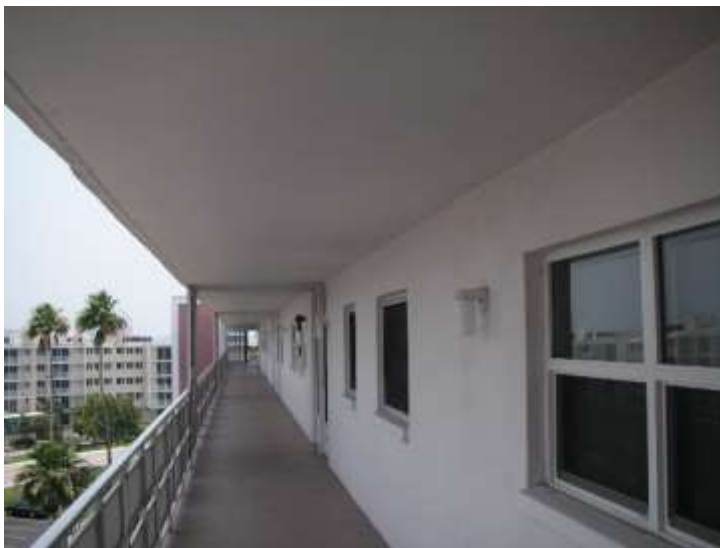
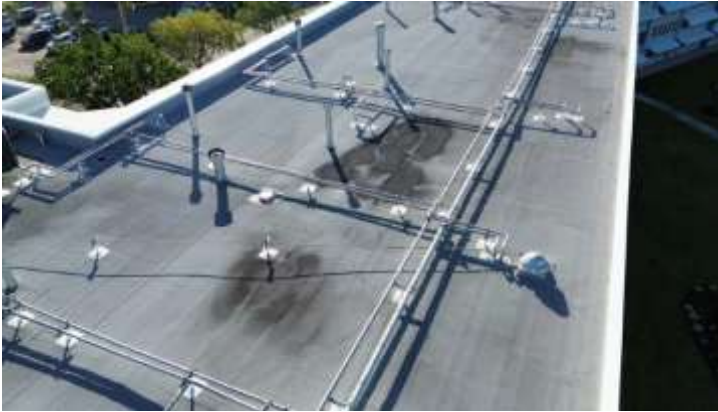
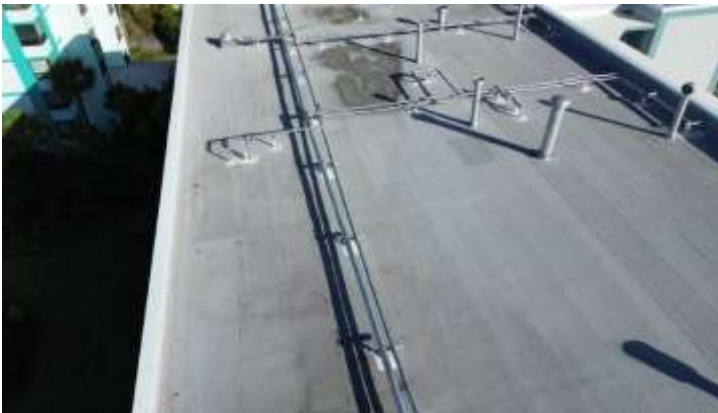
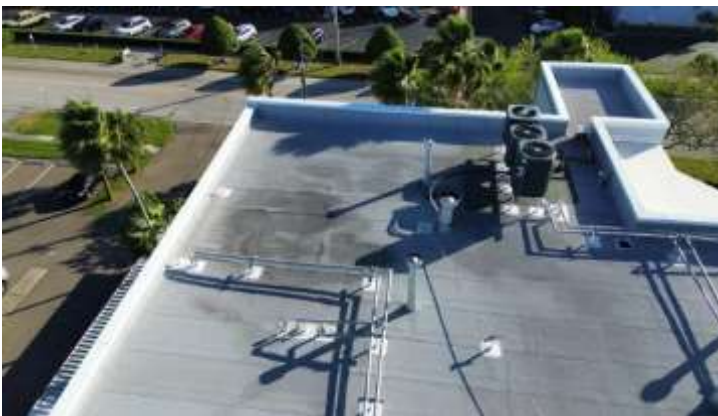
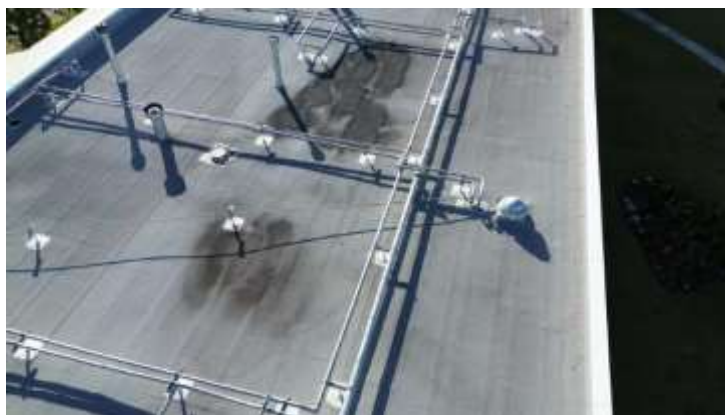
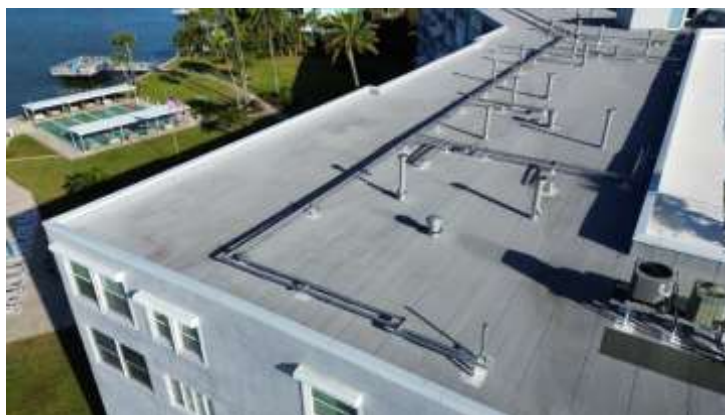
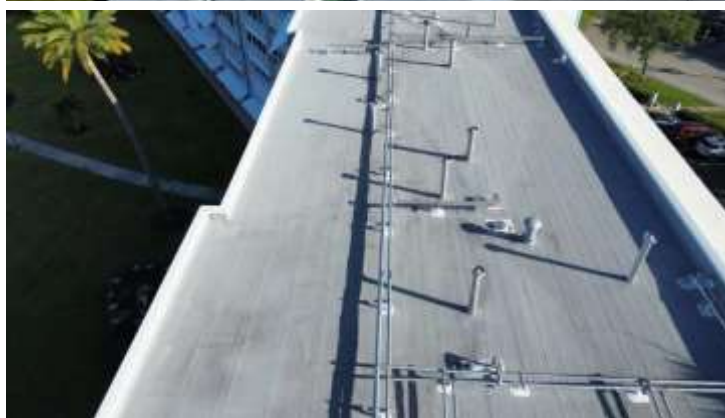
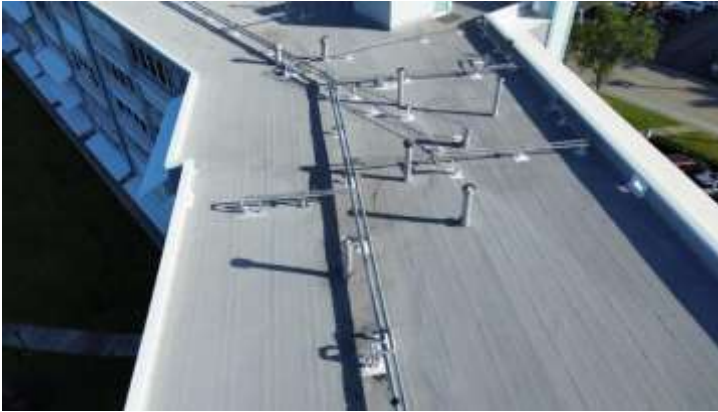
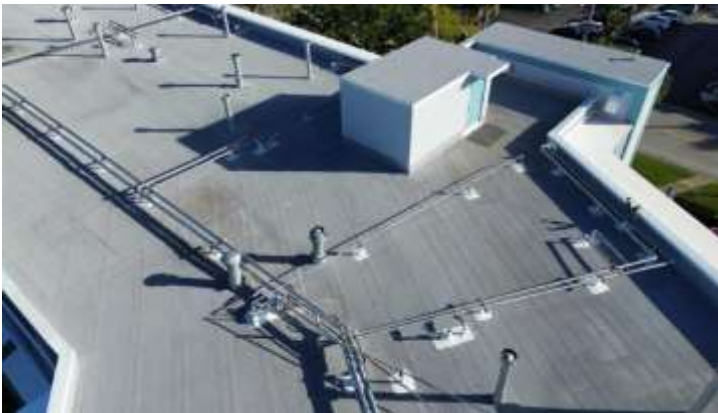
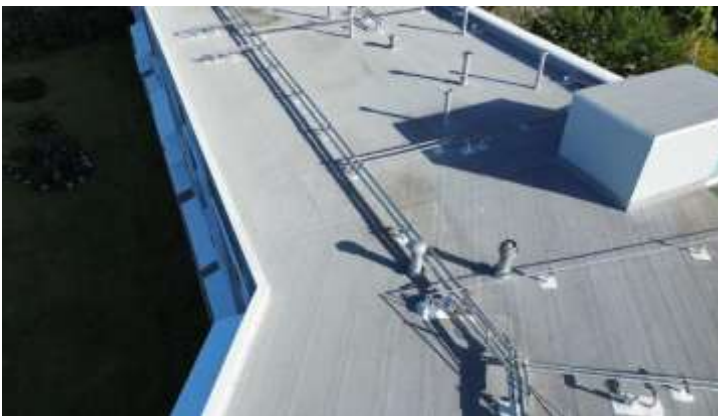
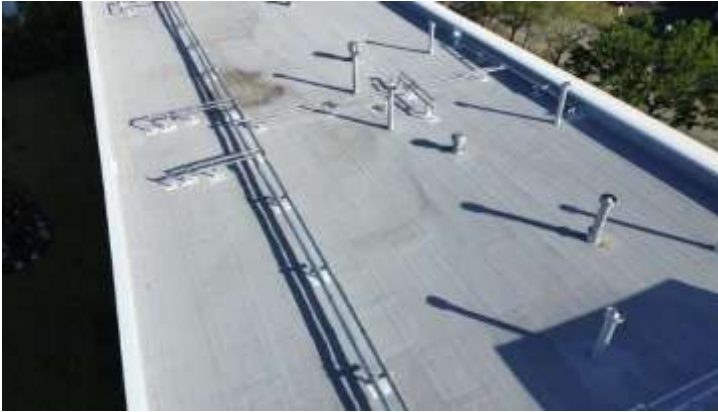
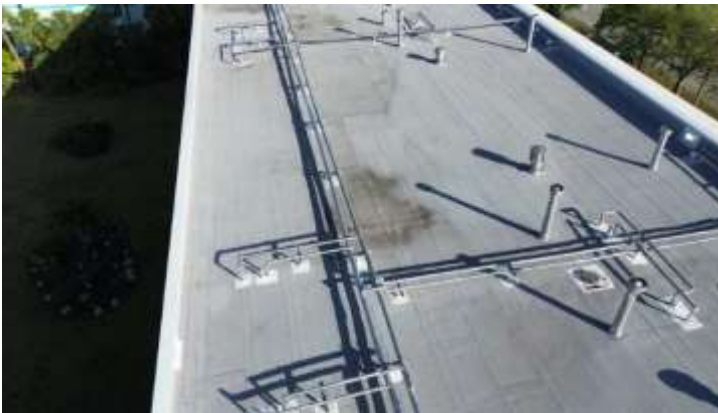
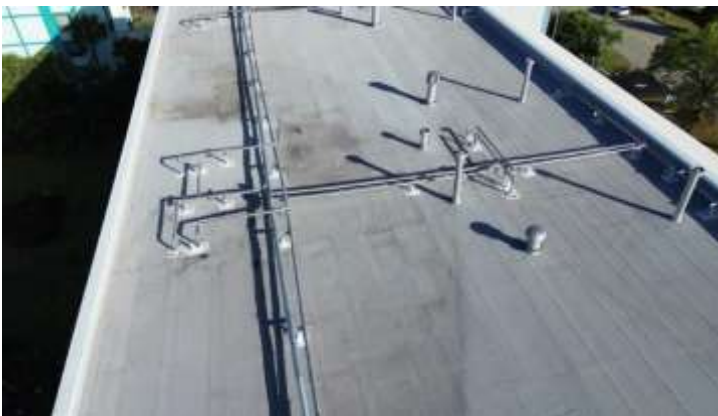
Roof Construction

Comments: | Reinforced Concrete Roof Deck
Inspection verified a roof structure composed of cast-in-place or pre-cast structural concrete designed to be self-supporting and integrally attached to the wall / support system. |
